IESCs Monitoring Report October 2023			SPL-REP-HSE-GEN-007
Revision: P6-1	Status: Re-IAA	Date: 24.10.2023	Page 5 of 99

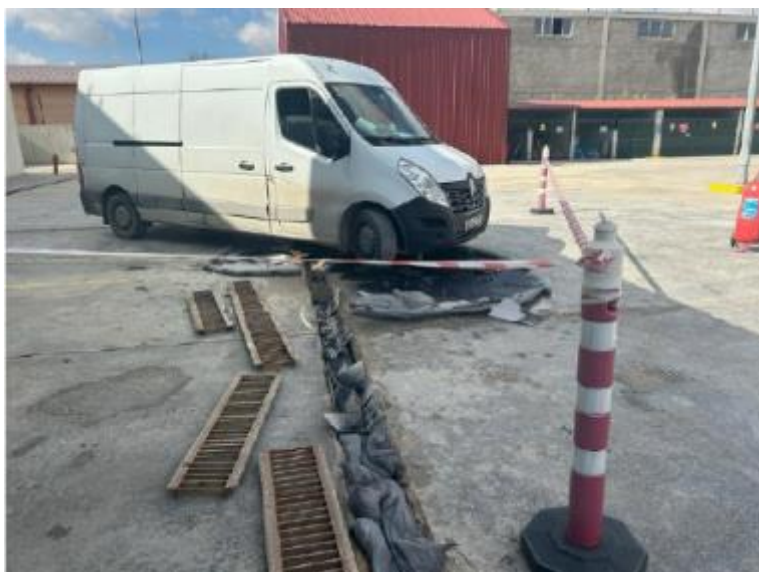
Figure 2.8 Accidental fuel spill at CS3/AMC

There has only been one environmental incident in 2023, which occurred on 7 March at CS3/AMC. It is noted that this is a 50% decrease in the number of environmental incidents since 2022 (when there were 2). A Contractor’s van had come to the facility to collect some materials from the warehouse and as it was exiting the building, the drainage grating lifted under the weight of the vehicle, puncturing the fuel tank and resulting in the spill of around 70 liters of diesel, as shown in Figure 2.7.

Employees at the site immediately blocked off the drainage channel to contain the spill and employed the fuel spill kits available at the facility to clear up the diesel. The unsuitability of the grating had previously been identified, and work was already planned for the summer to rectify the problem. Following this incident and before the works could be completed, the gratings were welded in place as a temporary mitigation measure to prevent any recurrence of the incident.

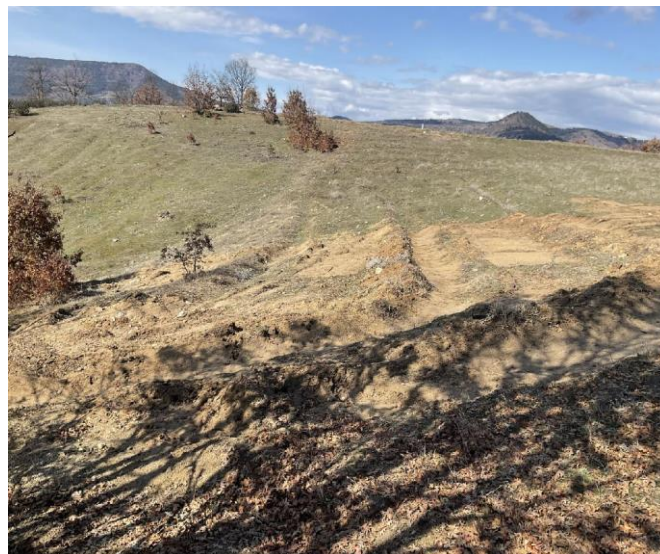
Figure 2.9 Repairs made at KP 1518+302

The IESC previously recommended that TANAP negotiate with the relevant Directorate of Forestry to allow surface run-off to be discharged into the natural gully, thereby following the natural contours of the slope and resulting in lower rates of soil erosion. During this site visit, the IESC was informed that following discussions with the Directorate of Forestry, TANAP are now allowed to divert surface run-off into the gully, which should at least partially reduce the soil erosion risk at this site. Further rectifications (with the permission of the Directorate) and repairs have also been completed, as shown in Figure 2.8 below (taken from a recent RoW Patrol Report). This site was not visited during 2023 and as such, the current status of soil erosion can not be verified. It will be requested that this site is a focus of the 2024 site visit. However, following the site visit, TANAP was able to provide the latest SME Land and Soil Erosion Survey Report (completed on 23 July 2023) for this site. The only reported issue was minor soil wash marks on the side slope breakers. The recommendations were for the site to continue to be periodically monitored by the ROW Patrol Teams and for the side slope breakers with minor erosion features to be reinstated manually (with a shovel).

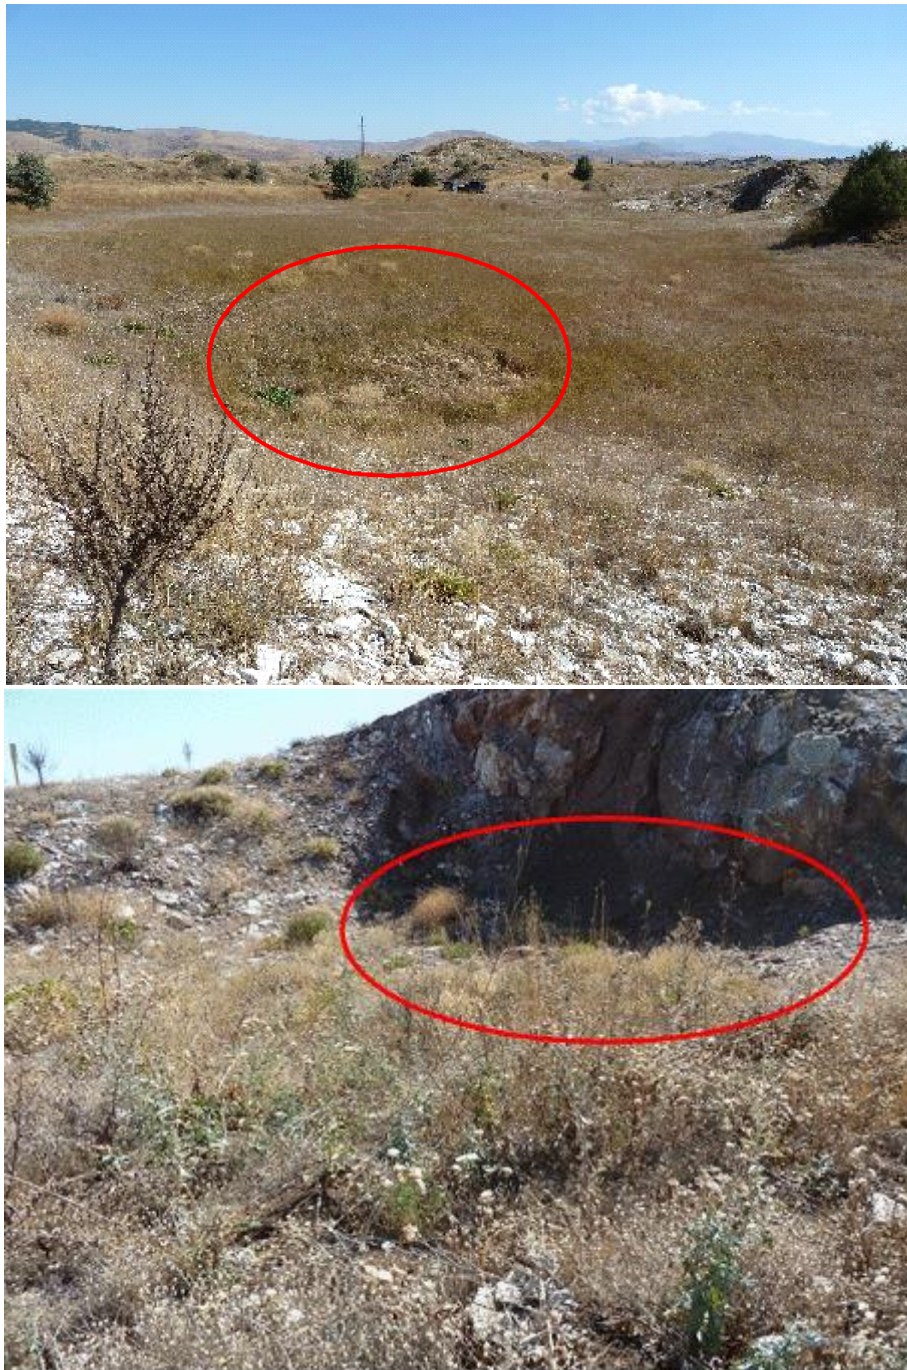
Figure 2.10 Two backfilled sinkholes at KP 657

The Karst Survey Report for 2022 (**TMS-REG-OPR-GEN-045**) completed by external SMEs has been provided to the IESC for review. The 2022 survey focused on 7 sections of the pipeline RoW covering approximately 7.7 km between KP 651+300 and 720+200 that had been classified as ‘Medium Risk’ following the 2021 survey. All sections are within Gypsum karstic units and included **KP 657+500-620**, in an area where dissolution type karstic features are very common. This corresponds with the site visited by the IESC, where two previous sinkholes were found in 2019 close to the centerline of the pipe. These were backfilled in 2019, and during the site visit were observed to be stable, as shown in Figure 2.9.

The IECS was informed that the base of the pipeline trench at this site is around 4m deep, and the main concern is that the bedding material beneath the pipe can be washed out. The Temelsu Survey Report states that backfilling the sinkholes is only a short-term solution, and that the on-going dissolution of gypsum is likely to cause the sinkhole entrances to be re-opened, which could result in the infiltration of surface water flow to the RoW and beneath the pipe. As such, this site is still classified as Medium Risk and monitoring (both visually and with geophysical methods) is recommended.

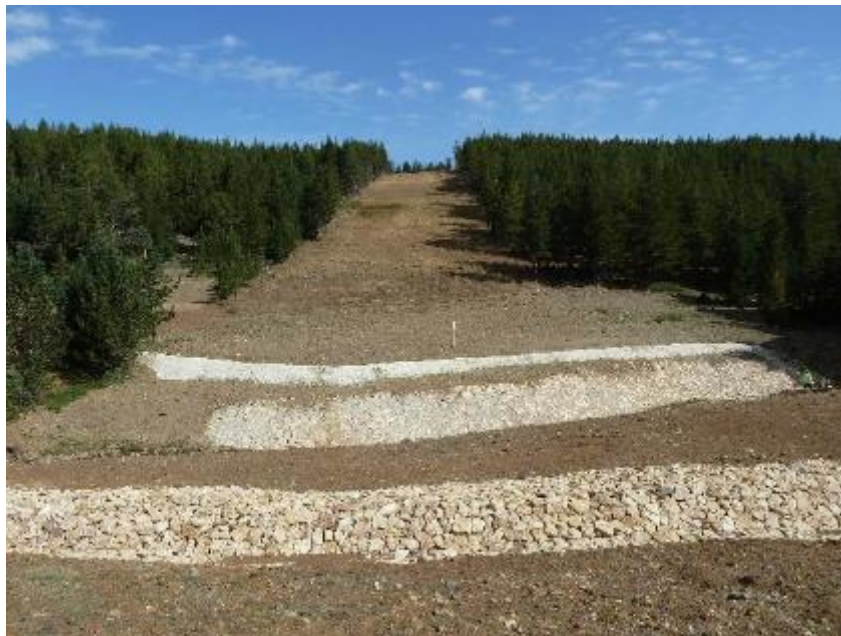
Figure 2.11 Additional permanent berm and slope breaker at KP 617+207

The first was **KP 617+207**, which is also the site of River Crossing 0276. There was an identified scouring problem at this site, that had been exacerbated by heavy rain and flash flooding typical of this area, and the Temelsu SME recommended the addition of further riprap protection on both riverbanks and the across the riverbed to ensure the minimum 2m depth of cover above the pipeline is maintained. This work was completed in 2021, along with the addition of a permanent berm and permanent slope breaker (as shown in Figure 2.10) due to the high erosion potential of the soil in this area.

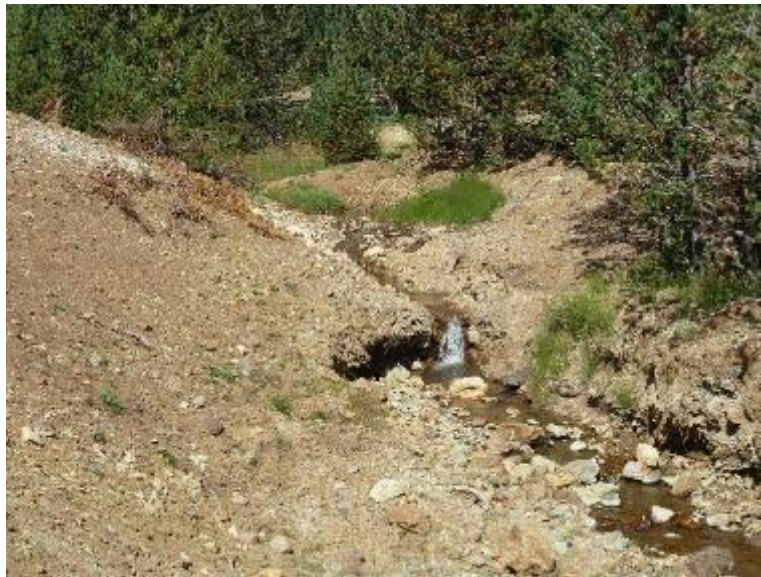
Figure 2.12 Undercutting of the riverbank at KP 616+207

There was some visible undercutting of the riverbank immediately upstream of the river crossing, as shown in Figure 2.11. However, this is outside of the RoW and is not expected to have any impact on the integrity of the pipeline so will not be addressed by TANAP. The IESC anticipates that there will be the need for maintenance activities at this site to clear the permanent slope breaker of deposited sediment, which was observed to already be accumulating. However, this site will continue to be monitored during the RoW Patrols, and at least 4-5 times per annum by the TANAP Lead Integrity Engineer for Geohazards (within the Integrity Management Department). As such, the IESC is comfortable that any future risks to integrity of the pipeline due to soil erosion will be detected and addressed in a timeframe commensurate with the scale of the problem.

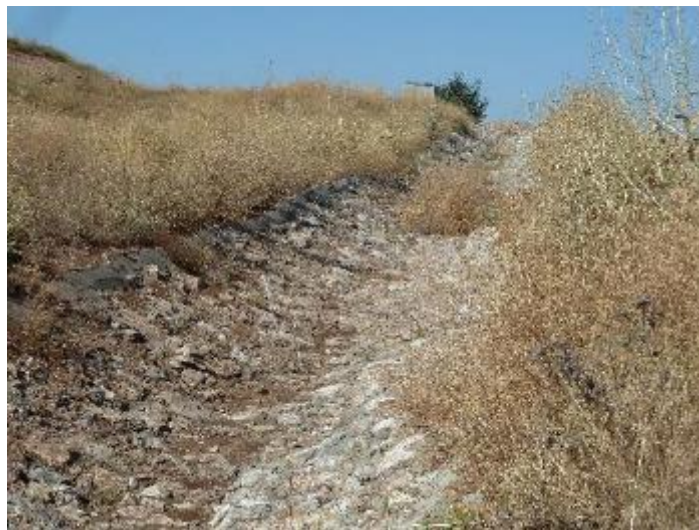
Figure 2.13 Permanent flood diversion channel

The second site visited was **KP 702+500**. Three years ago, an existing 60-inch irrigation pipe on the site was broken and the volume of water released resulted in a large amount of the cover material being washed away on the RoW, exposing the pipe. The immediate action taken was to contact the state water authority and have the supply turned off whilst the maintenance team were mobilised to backfill the trench. However, during subsequent discussions with the landowner, it was determined that this problem could recur. As such, the geo-technical contractor was engaged to construct engineering protection measures in the form of replacing the temporary slope breakers with permanent ones, and the addition of two rock lined, concrete flood diversion channels (one on the lateral slope and the other immediately next to the irrigation pipe) as shown in Figure 2.12.

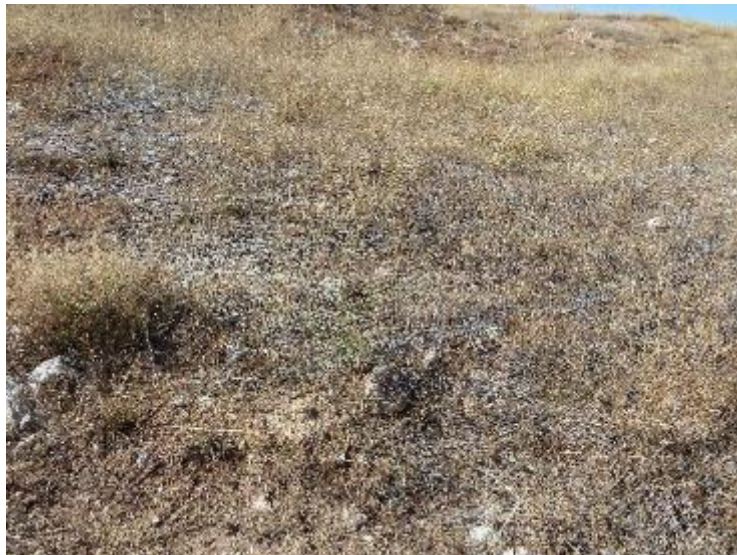
Figure 2.14 Jute matting and revegetation at KP 702+500

Jute matting was also laid down and hydro-mulching used to help re-vegetate the site and limit any further soil erosion. The IESC observed good levels of re-vegetation, and there were no signs of soil erosion, as illustrated in Figure 2.13.

The IESC was encouraged that TANAP has taken a proactive, collaborative approach to integrity management at this site. Through active engagement with the landowner, effective forward planning has been adopted, and measures taken to limit/avoid future risks to the integrity of the pipe, rather than relying on a reactive approach if/when the situation happens again.

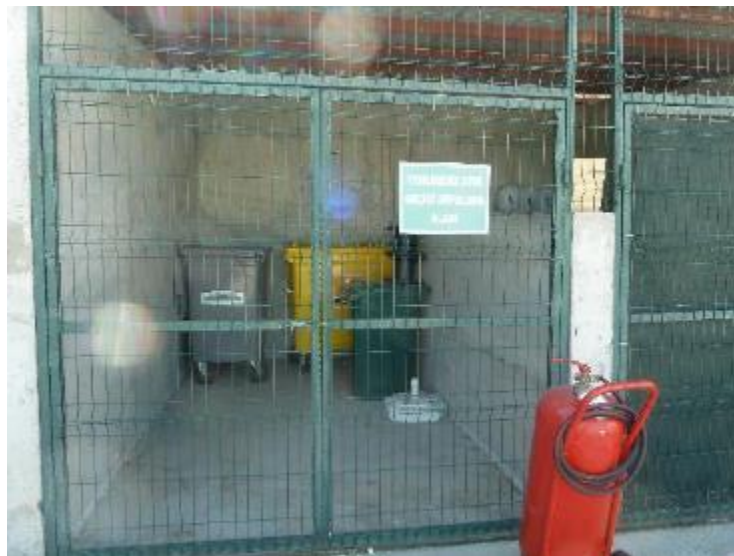
Figure 2.15 Good practice non-hazardous waste storage at CS3

Segregated waste bins are being provided around the station for paper, plastic, glass and metal, clearly labelled, and there was no mixing of waste types observed. Such effective at source segregation is commended, as it facilitates the removal of waste by the relevant licensed third-party company for recycling. The external waste storage area comprises units for different waste streams that are all locked and covered, with impermeable flooring. Each unit is clearly labelled, and good housekeeping practices were being demonstrated, as shown in Figure 2.14.

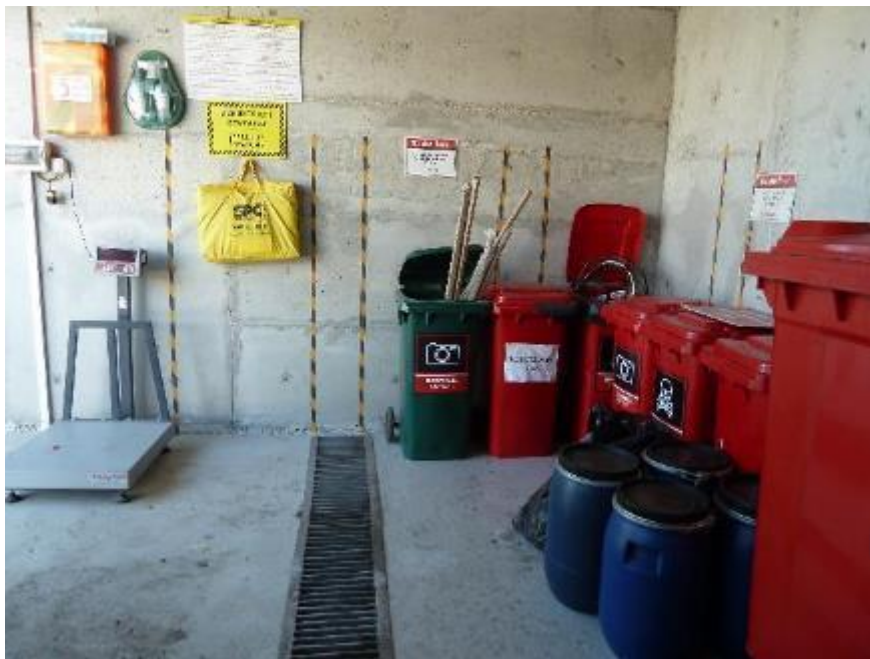
Figure 2.16 Hazardous waste storage practices at CS3

Within the hazardous waste storage units, there was also a drainage channel on the floor that led to a dedicated collection tank. Universal spill kits, first aid kits and eye wash stations were also provided in case of an accidental spill. In accordance with good international practice, there was an up-to-date hazardous waste register that indicated the date of arrival of the waste, the types of waste and volumes being stored. Material Safety Data Sheets (MSDS) were also available. However, hazardous waste containers were mostly, but not all, clearly labelled as illustrated in Figure 2.15 (where the blue containers are missing labels), which is a non-compliance with the requirements of the Pollution Prevention Plan for Operations (TNP-PLN-ENV-GEN-009). This observation corresponds with the findings of the internal environmental compliance review (see Section 2.3.4.5) and should be easily rectified.

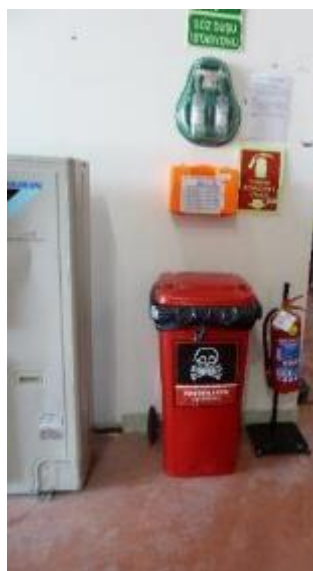
Figure 2.17 Hazardous waste bin in the warehouse at CS3

Inside the warehouse, there was a dedicated hazardous waste bin that is clearly labelled, with a lid. There were also a first aid kit and eye wash located immediately next to the bin. One minor recommendation is that the spill kit that is located at the entrance to the warehouse, next to the glass and domestic waste bins, be placed next to the hazardous waste bin where it will be more easily accessible in the event of an accidental spill.

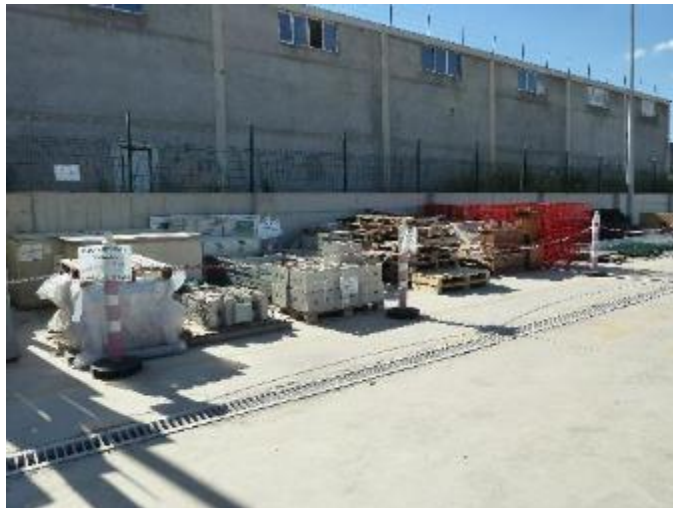
Figure 2.18 External materials storage area at CS3

Both the external materials storage area and materials storage within the warehouse were observed to demonstrate best practice. The external storage area was cordoned off, the different types of materials

were clearly labelled, and the area was very tidy and organised so that there were no H&S hazards. This is illustrated in Figure 2.17.

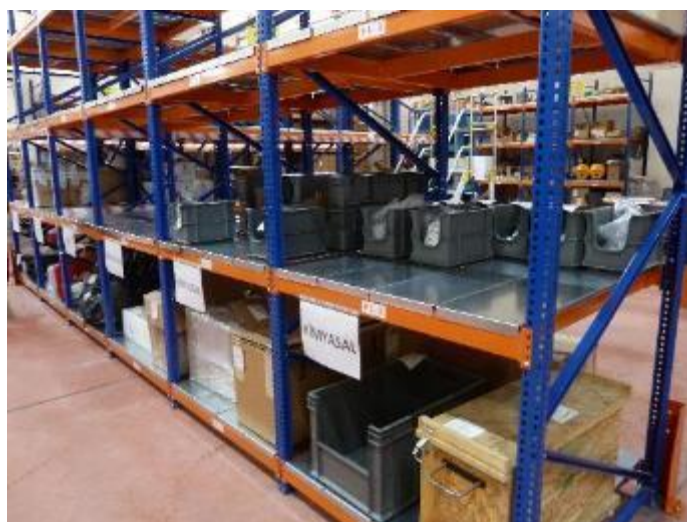
Figure 2.19 Good practice materials storage at CS3

Inside the warehouse, similarly high levels of housekeeping were observed with all materials being stored on off the floor shelving, within adequate secondary containment where required, and clearly labelled (see Figure 2.18).

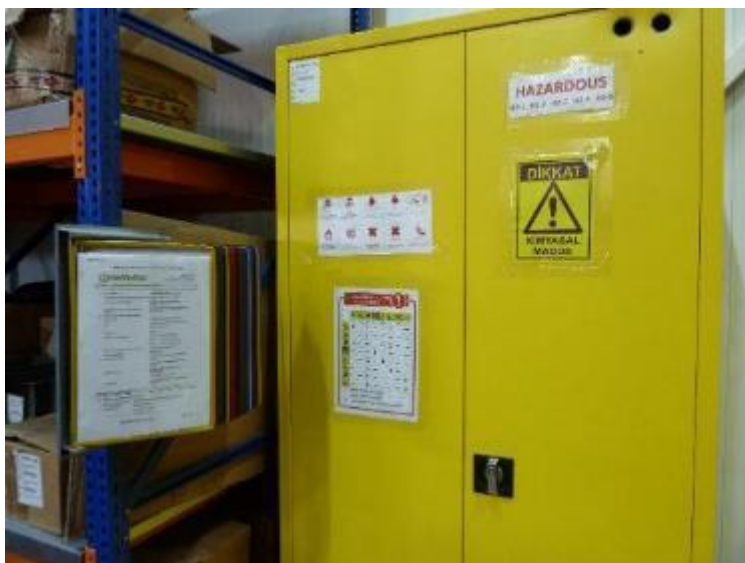
Figure 2.20 Hazardous materials storage at CS3

Hazardous materials were being stored within a locked, clearly labelled cupboard within the warehouse. A spill kit was located next to the cupboard and in accordance with best practice, MSDSs were available, and a storage compatibility matrix had been completed and was displayed, as shown in Figure 2.19.

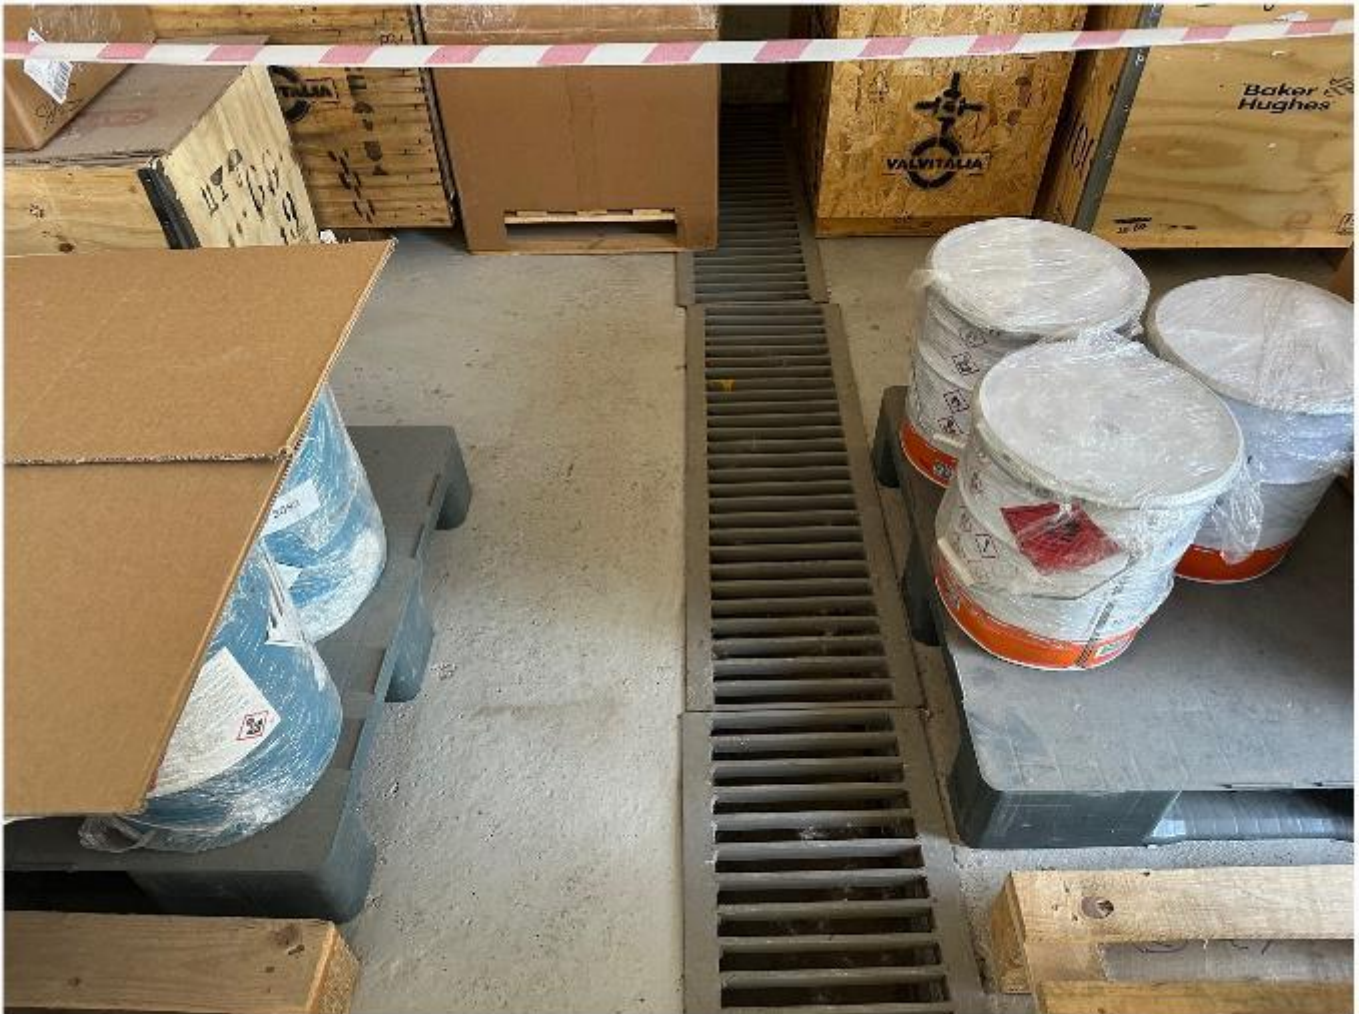
Figure 2.21 Storage of poisons and flammables together

2.1 (2.5.3.4)	Hazardous waste containers at CS3 (AMC) were not all clearly labelled, in addition to the incompatible storage of flammable and poisonous materials.	All employees responsible for the storage of hazardous materials and hazardous waste at CS3 (AMC) should be given refresher training, and additional checks carried out over the next 6 months by the Environmental Department to	PC	PR2 / PS2 OHS PR3 / PS3 Pollution Prevention and Control	Open

After a thorough inspection of the facility only one OHS non-compliance was identified which was the incorrect storage of poisons and flammables within the same storage area (Figure 2.20). Storing poisons and flammables together is a significant OHS hazard. If these chemicals mix, they can create a variety of dangerous situations, including:

- Fires and explosions: Some poisons can react with flammable materials to cause fires or explosions. For example, storing chlorine gas with gasoline can create a highly explosive mixture.
- Toxic fumes: If poisons and flammables are mixed, they can release toxic fumes that can be harmful to human health. For example, mixing bleach and ammonia can create chlorine gas, which is a highly toxic gas that can cause respiratory problems and even death.
- Corrosive substances: Mixing poisons and flammables can also create corrosive substances that can damage property and injure people. For example, mixing acid and base can create a corrosive substance that can burn skin and damage metal.

In addition to these specific hazards, storing poisons and flammables together can also make it difficult to respond to emergencies. If there is a fire or other emergency in an area where poisons and flammables are stored together, it can be difficult for firefighters and other emergency responders to safely access the area and extinguish the fire or contain the spill. **It is recommended that all employees responsible for the storage of hazardous materials and hazardous waste at CS3 (AMC) are given refresher training, and that additional checks are carried out over the next 6 months by the HS and Environmental Departments to ensure the correct hazardous waste/materials storage measures are being implemented.**

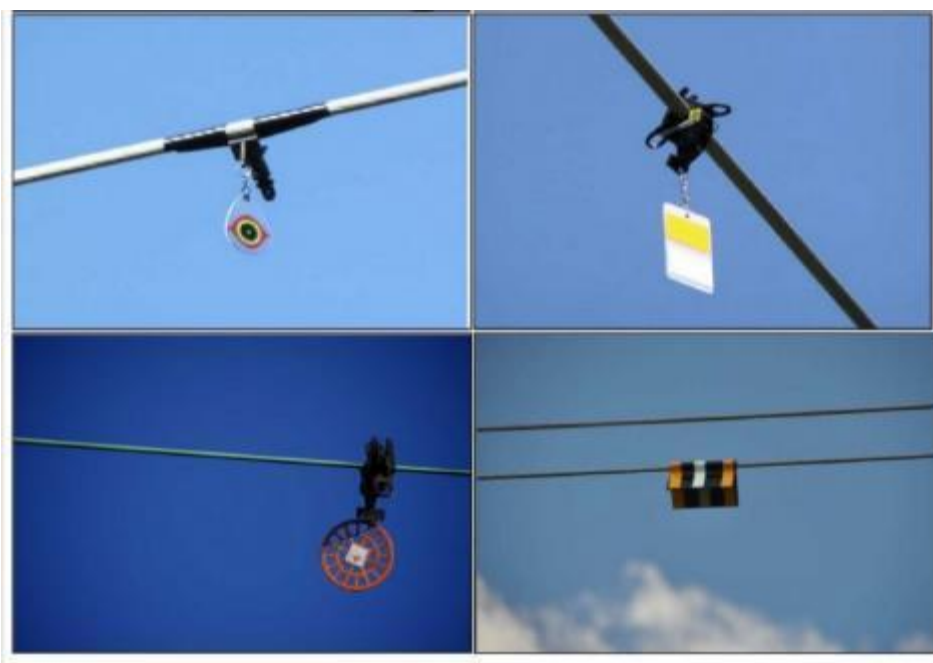
Figure 2.26 Examples of bird flight diverters

Based on the Çınar’s 2019 monitoring results (16 carcasses found on monitoring routes, 11 likely died due to collision with the transmission lines rather than electrocution) TANAP have continued to commission the bird monitoring in 2020 and 2022 only at BVS21. On all subsequent survey visits (autumn 2019, 2020 and 2021; spring 2020, 2021, and 2022 and summer 2021) no further bird carcasses were observed. Despite this, TANAP continued bird monitoring at this location. It was recommended by the IESC that once the 2022 monitoring has been completed, TANAP with their consultants – ASSYSTEM; should make a decision on the need for further monitoring on this transmission line.

It is now understood that during the 2023 monitoring, five dead birds were found under the transmission line at BVS21. ***It is therefore recommended that bird flight diverters (BFDs) are installed on the line, to make it more visible to birds, so that they can see it and take evasive actions earlier, to avoid collision.*** There are many types of BFDs, some of which are suitable for installation on active power lines, through the use of a drone. The bird diverters should be installed on the line, before the spring movement of birds or as soon as practicable, and the efficacy monitored for a further two years.
