IESCs Monitoring Report October 2022			SPL-REP-HSE-GEN-006
Revision: P6-0	Status: IAA	Date: 31.10.2022	Page 1 of 96

<p><b>TANAP</b></p> <p><b>TRANS ANATOLIAN NATURAL GAS</b></p> <p><b>PIPELINE PROJECT</b></p>

## IESC Monitoring Report October 2022

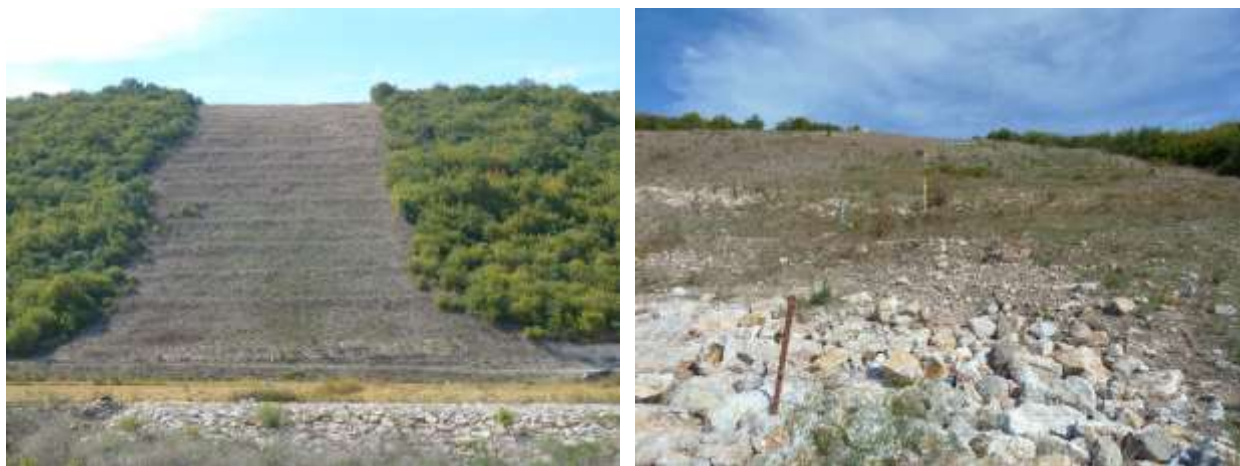
**Figure 2.5: Condition of the slopes on both sides of the Gönen River crossing**

This slope is currently classified as 'Low Risk' for soil erosion, and this site is surveyed by Temelsu for geo-hazard risks in relation not only to soil erosion on steep slopes but also as a river crossing and for landslide risks. There are 2 passive landslide areas (LS449 and LS 309) on either side of the right of way on the eastern side of the Gönen River crossing. During the 2021 landslide inspection survey no movement was detected (only some settlement that would naturally be expected following construction) and whilst this area was kept under observation annually for 4 years to ensure there was no impact post construction, landslide monitoring will now be reduced to every 5 years. The aerial surveys (by plane and drone) will also enable clear comparisons of the condition of the area to be made. The IESC is therefore comfortable that any potential issues at this site will be identified in good time as part of the planned geo-hazard monitoring, as well as through the RoW Patrols and aerial surveys.

There were no visible soil erosion issues at this site and vegetation on the slopes on both sides of the River was well established, especially considering the thin/rocky soil layer (as shown in Figure 2.5).

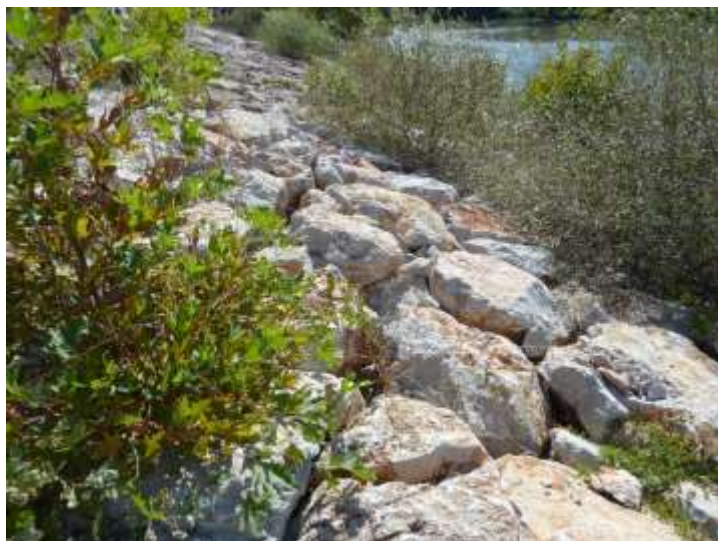
**Figure 2.6: Rip Rap at KP 1661 in good condition**

There is 2m thick rip rap along the riverbanks at the pipeline crossing point and following three flood events since the completion of construction, the condition of this structure has no obvious deterioration (as shown in Figure 2.6). The IESC therefore has no further concerns relating to this site.

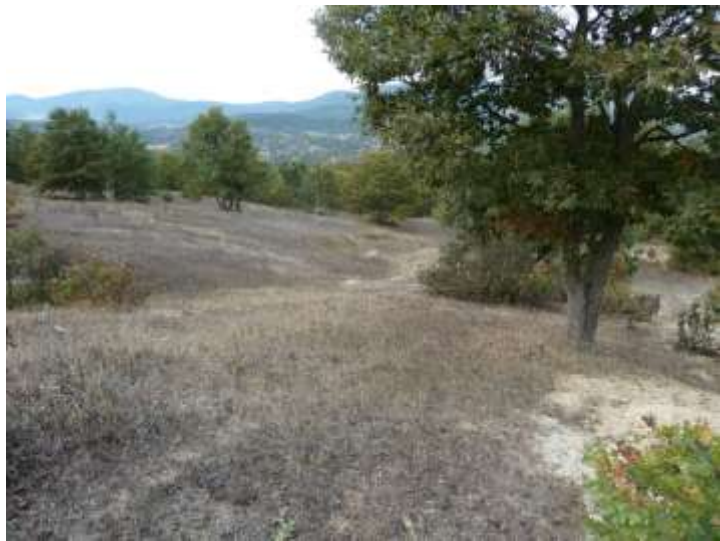
**Figure 2.7: Natural gully off the RoW**

There are three main factors contributing to the level of geo-hazard risk at this site. First, the soil is weathered granite sand, which has very high erosion potential. Second there is a small river crossing (RVX4-0686) that cuts across the RoW, which had caused the previous deep gully to form. Third, whilst there is a natural gully at the foot of the lateral slope (as shown in Figure 2.7), which would be the obvious place to discharge run-off/drainage from the RoW, it is within Government controlled Forestry land and TANAP are not permitted to divert water from the RoW into this gully.

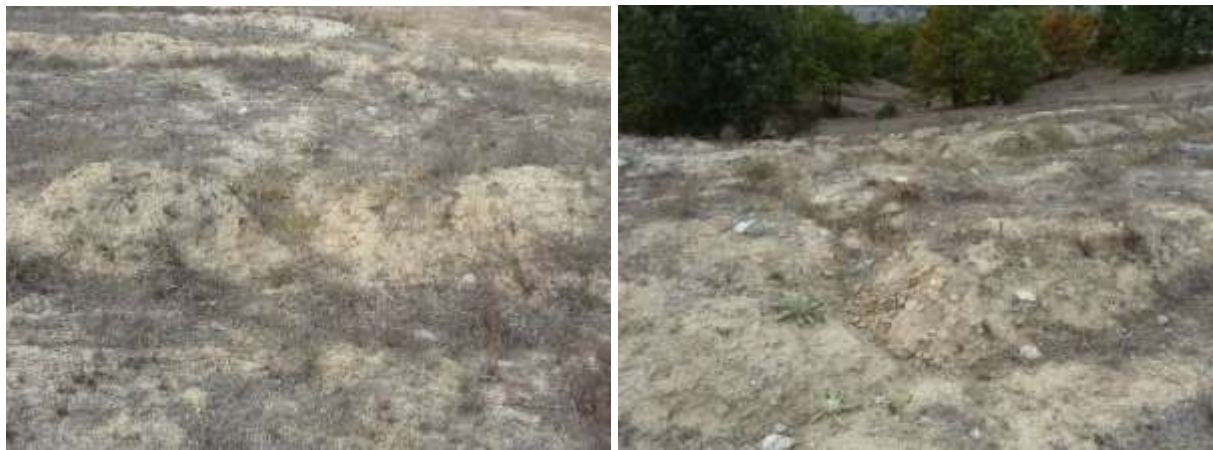
**Figure 2.8: Breaches of slope breakers and gullies forming**

The Aftercare and Monitoring Report for Lot4: June-July-August 2021' (PLK-REP-ENV-PL4-026) identified a soil erosion issue at **KP 1518+302** including an 80 cm deep gully, breaches in the slope breakers and extensive rilling parallel to the RoW. This was added to the Contractor Defect list as a medium priority defect on 6 August 2021 and following the last remote audit TANAP confirmed that the defect was closed and provided the Warranty Defect Form signed on 27 December 2021. The IESC requested a visit to this slope to verify that the repair works completed have been effective.

Less than a year after the repair works were conducted, some of the slope breakers at this site have been breached and there are clear signs of rilling and gullies forming (as shown in Figure 2.8). Furthermore, there is another deep gully developing where the river crosses the RoW, as illustrated in Figure 2.9. As such, further repairs are clearly required at this site (which will be conducted by the Maintenance Department).

During the repair works that were carried out, the RoW at this site was fully regraded, the existing slope breakers were repaired and extended, and additional slope breakers were added (so that there are now slope breakers every 10m) with the aim of diverting surface water off of the RoW (including from the parallel access road).

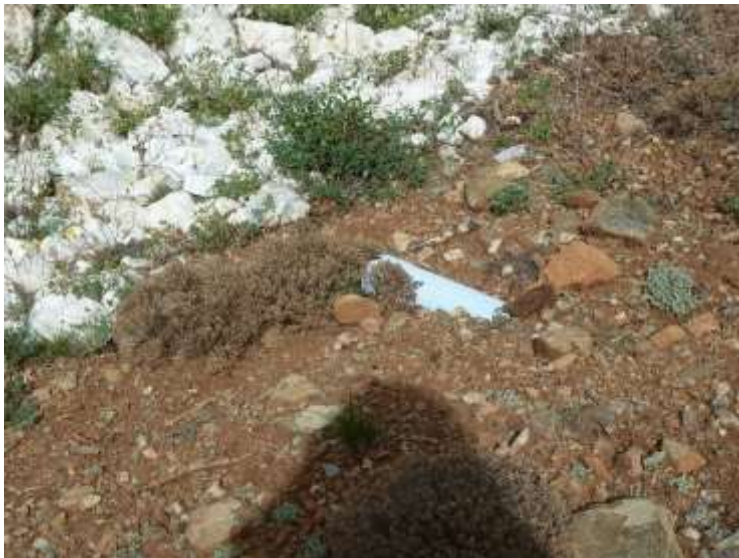
**Figure 2.10: Pipe discharging from the trench to a permanent slope breaker**

drainage system discharging to the slope breakers from the pipeline trench on this slope to prevent any subsidence within the trench, as shown in Figure 2.10.

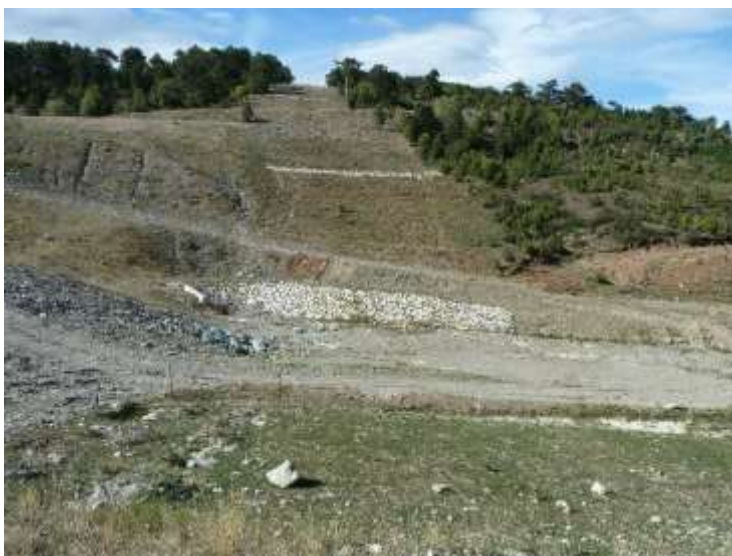
**Figure 2.11: Third party crossing at KP 1433+300**

At **KP 1433+300** the RoW has been crossed by a temporary third party access road, to facilitate the construction of a nearby dam pipeline. The geology at this site is serpentine and there is a landslide risk. As such, any uncontrolled excavations could trigger a landslide, reducing slope stability and risking pipeline integrity. The design for the crossing that was initially proposed to TANAP was rejected as it crossed the RoW diagonally. Following negotiations, the design that was eventually accepted by TANAP crosses the right of way vertically in the valley, as shown in Figure 2.11.

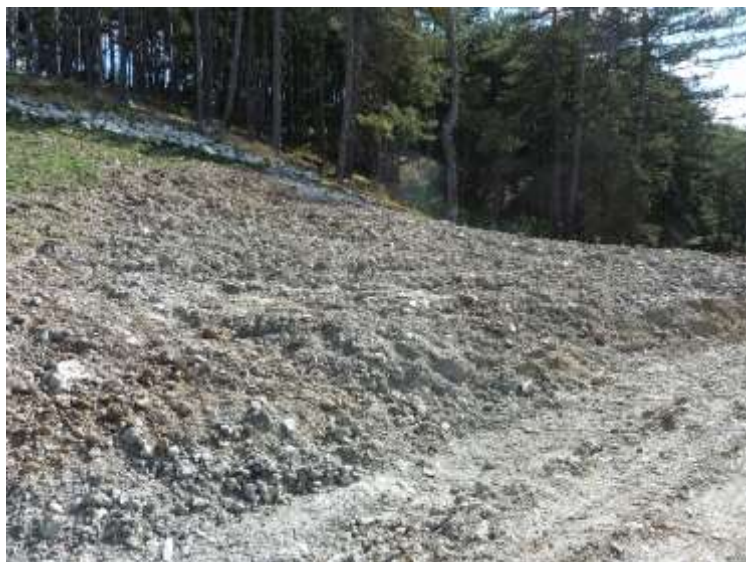
**Figure 2.12: Repaired damage to the RoW**

A Third Party Crossing Protocol is in place to ensure that the RoW will be reinstated according to TANAP's specifications. Some limited damage has been caused by dam construction traffic to the RoW adjacent to the existing access road, which has been repaired to an acceptable level by the third party as shown in Figure 2.12.

The IESC is comfortable that TANAP is directing the third party interventions effectively at this site, to ensure that the integrity of the pipeline is protected.

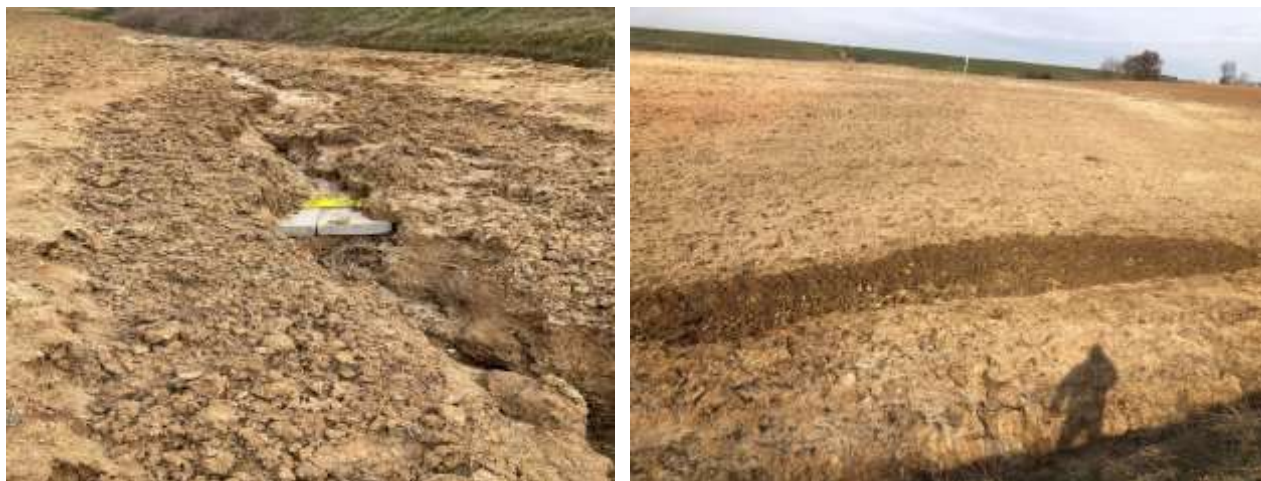
**Figure 2.13: Concrete slab exposed and gully backfilled**

There were no 'High Risk' sites for geo-hazards in the schedule for this site visit. As such, the IESC is not able to extrapolate observations made in Lot 4 across the entire project. However, 3 samples of high priority findings by the RoW Patrol Teams made during 2022 were provided for review. These included, at **KP 1796+950**, concrete slabs being exposed on the pipeline in a deep gully, which was subsequently backfilled in by the Maintenance Team as shown in Figure 2.13.

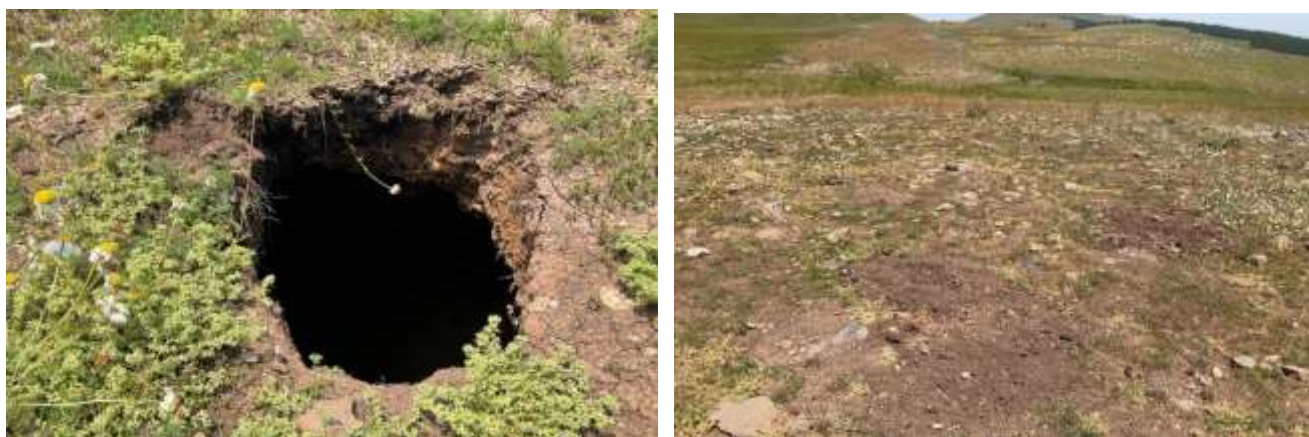
**Figure 2.14: Settlement pit backfilled**

Additionally, a settlement pit around 100cm deep had formed at **KP 189+415**, which was also filled in by the Maintenance Team using hand tools, as shown in Figure 2.14.

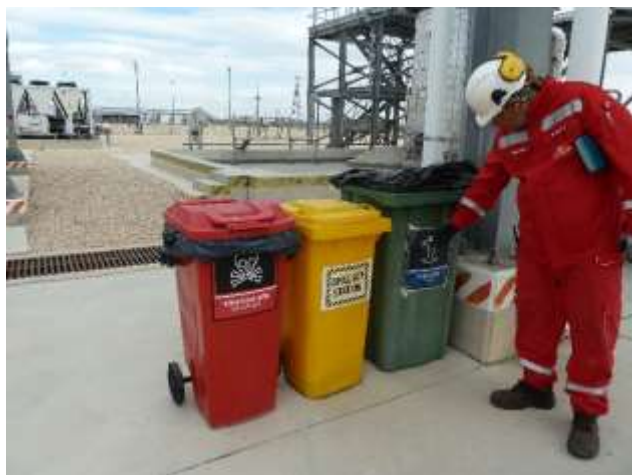
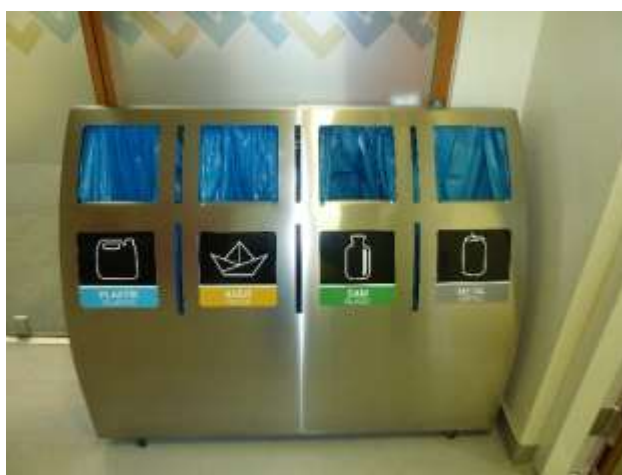
**Figure 2.15: Segregated waste bins at CS5/MS2**

The IESC observed generally excellent waste management practices at both CS5/MS2 and the MCC, in compliance with the Waste management Plan for Operations (TNP-PLN-ENV-GEN-007). Within and external to both buildings there are segregated waste bins, clearly labelled (as illustrated in Figure 2.15) in accordance with the Waste Management Procedure and there was no mixing of waste streams within the bins observed.

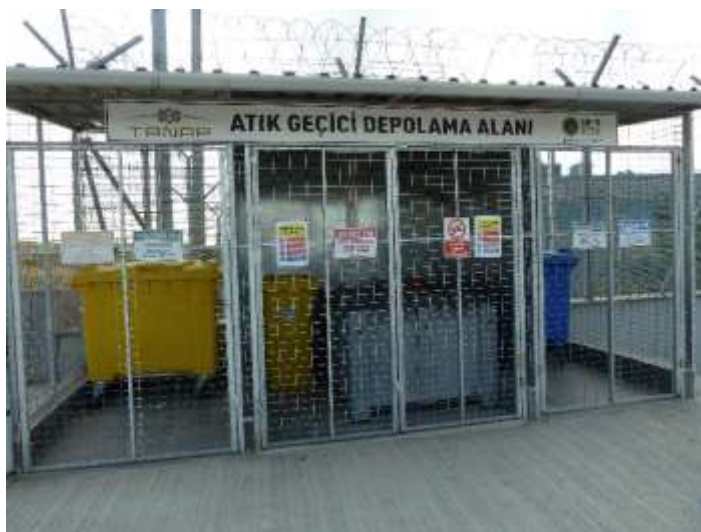
**Figure 2.16: Waste Storage Area at the MCC**

At the MCC, all waste is stored outside of the security fence in a dedicated, covered and locked waste storage area as shown in Figure 2.16. There is clear labelling, an impermeable floor and all waste streams were within appropriate containers with lids. A spill kit was also present. It was explained to the IESC that hazardous waste at this facility is mainly generated as a result of conducting oil changes in the generators and cannot be kept on site for more than 180 days before removal by a licensed contractor. The local municipality collects all non-hazardous waste for recycling.

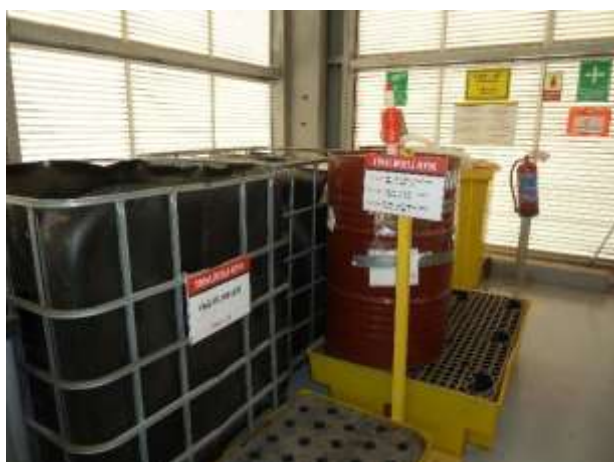
**Figure 2.17: Adequate secondary containment and clear labelling of waste**

Other best practice measures observed included all waste containers being accurately and clearly labelled, including with the Turkish regulatory waste codes (as per Appendix 1 of the Waste management Plan for Operations) and being stored within adequate secondary containment, as illustrated in Figure 2.17: Adequate secondary containment and clear labelling of waste.

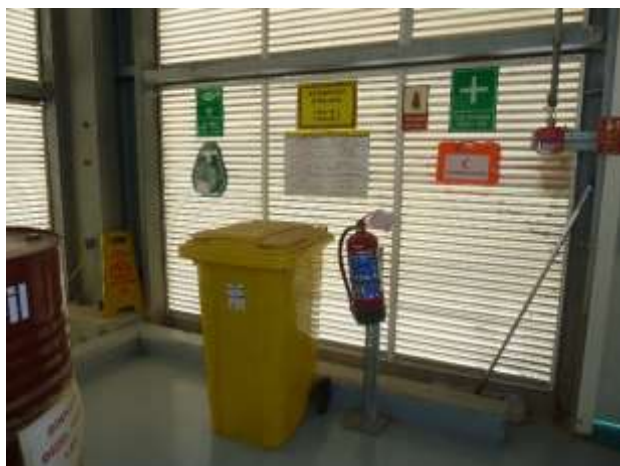
**Figure 2.18: Waste incident response equipment**

There was also an appropriately stocked spill kit in the building, along with a fire extinguisher, first aid kit and eye washing facilities, as shown in Figure 2.18: Waste incident response equipment and chemicals were being stored within a locked cabinet.

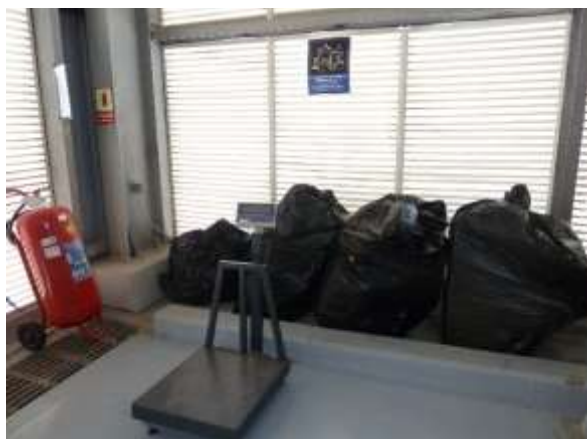
**Figure 2.19: Waste weighing scales**

To facilitate reporting on the volumes of waste generated at the Station to TANAP Head Office in Ankara, weighing scales are located within the storage area, as shown in Figure 2.19. Waste declarations for the wastes generated (volume and waste streams) at MS 1, CS 1, CS 3, CS 5 /MS 2, MS 4, the MCC and Ankara Headquarters in 2021 were submitted via the online Waste Declaration System of the MoEUCC in accordance with the Turkish Waste Management Regulations.

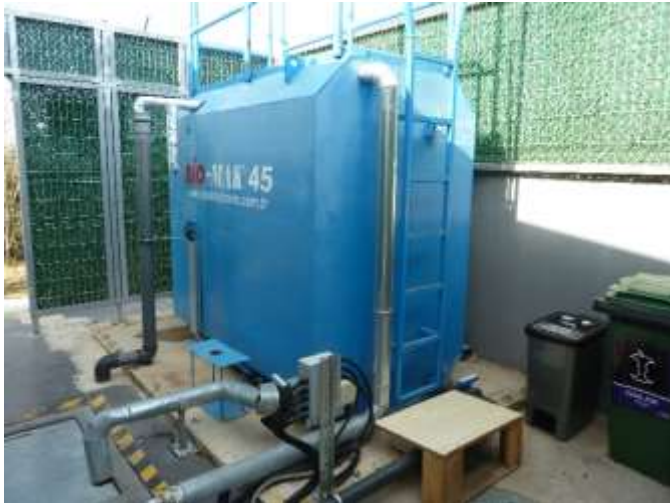
**Figure 2.20: Biological wastewater treatment plant at the MCC**

Both of the facilities visited have on-site biological wastewater treatment plants (WWTP) for the treatment of domestic wastewater. The MCC treatment plant (shown in Figure 2.20: Biological wastewater treatment plant at the MCC) has a capacity of 6.75 m<sup>3</sup> but this is not being fully utilised, with around 2m<sup>3</sup> wastewater currently being generated daily. This volume may increase if the SOCAR building on site becomes occupied. The treatment process comprises 4 hours of aeration, 1 hour of settlement and 15 minutes of discharge.

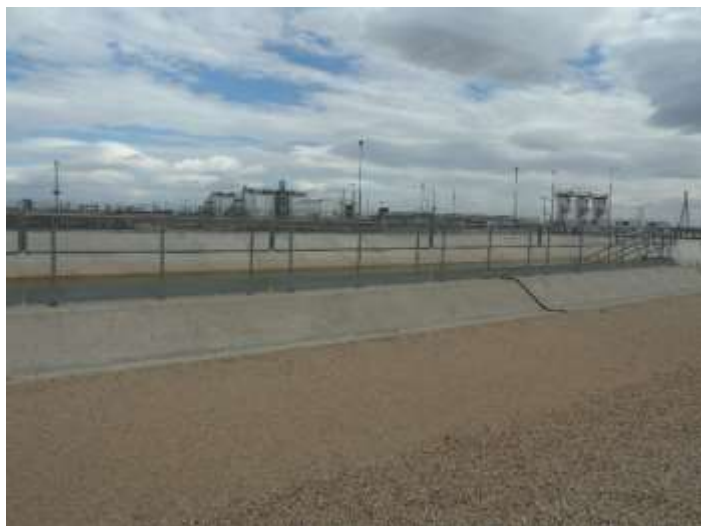
Figure 2.21: Surface water collection pond at CS5/MS2

The surface water drainage system at CS5/MS2 collects all run-off from the station and discharges it to a large collection pond on site (as shown in Figure 2.21). There is no outlet from the pond and the water is allowed to evaporate naturally. It is assumed that the pond will need to be cleared of sediment only around every 20 years.
