IESCs Monitoring Report October 2024			SST-REP-HSE-GEN-001
Revision: P6-0	Status: IAA	Date: 18.11.2024	Page 4 of 94

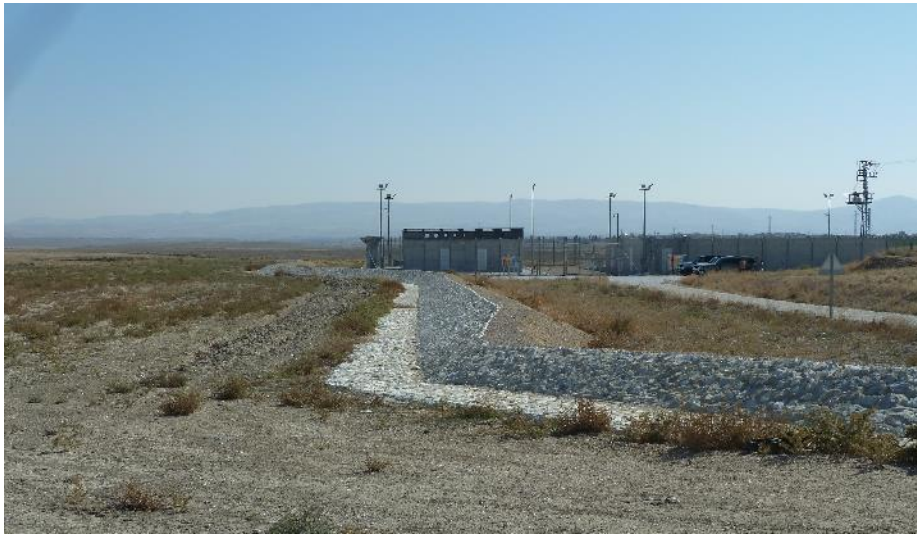
Figure 1: BVS-37 New Flood Protection Berm

As TANAP is recalculating the flood risk for all AGIs, it has become apparent that flood protection measures will also need to be redesigned for some additional BVSSs, where flood flow rates in nearby watercourses are now too low.

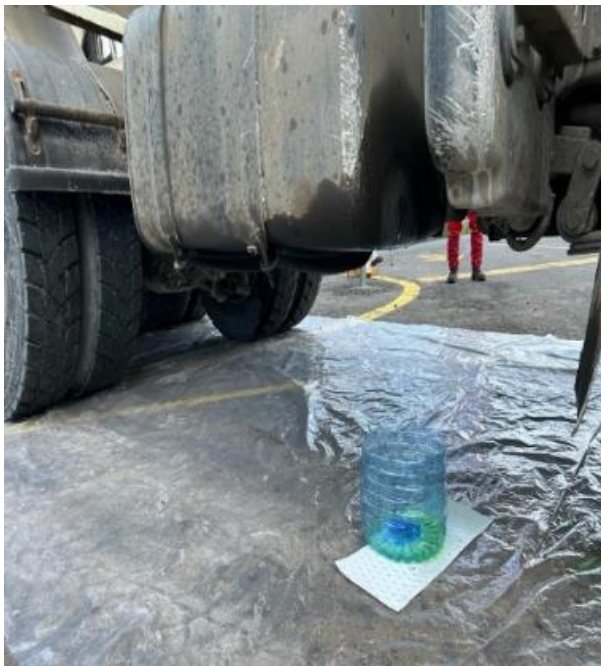
Figure 8: Diesel leaking from the concrete mixer and spill containment

A plastic sheet was immediately laid over the road under the vehicle and a plastic container placed beneath the drip to contain the spill. The spilled diesel was then cleaned up with an absorbent chemical pad. Whilst the consequences of the incident were limited, as the spillage was onto tarmac and not bare soil, TANAP employees correctly followed the requisite investigation and reporting protocols. The resulting action taken was to liaise with the concrete company management to request that their vehicles be pre-checked for leaks before making deliveries.

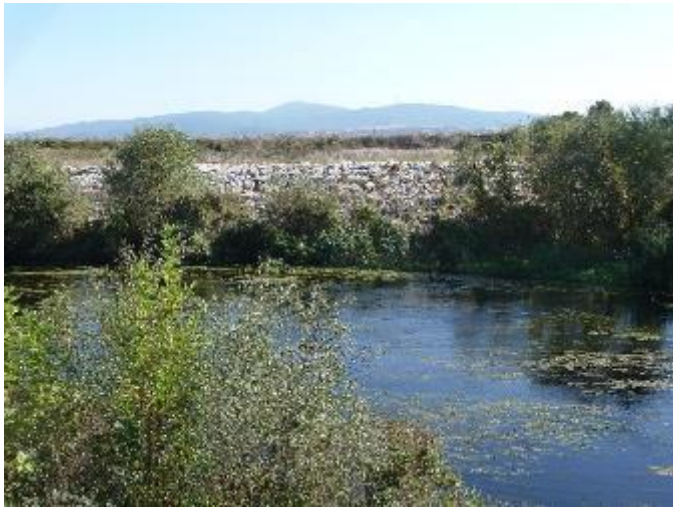
Figure 9: RVX2-0038

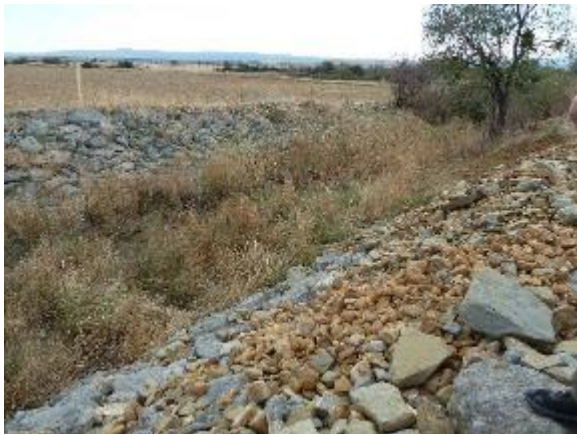
The river at **RVX4-0823** is normally dry and only has any flow levels following heavy rainfall. Rip rap has been installed at this location to protect the pipeline at the crossing point; however, it is only monitored every 5 years by the SME (as a notable priority site). There are no signs of any soil erosions (see Figure 10), and the classification is considered by the IESC to be appropriate.

Figure 10: RVX4-0823

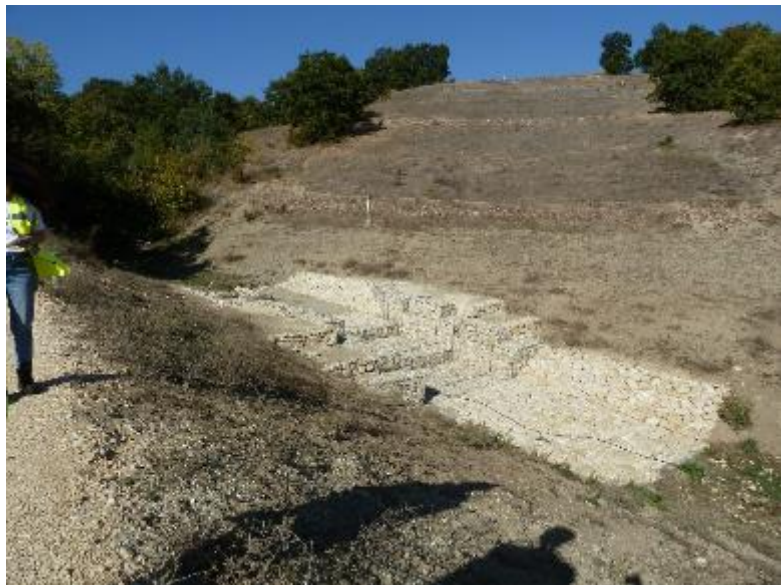
An example of where geo-hazard risk identified through TANAP monitoring has been effectively addressed is at **RVX4-0699/KP1534+885**. The steep slope at this location is stable following reinstatement, with good levels of re-vegetation. Three permanent and three temporary slope breakers have been installed, which were observed by the IESC to be effectively preventing soil erosion. However, the SME river crossing survey identified channel degradation and scouring up to 1m deep downstream of the river crossing point along with a 'huge amount of vegetation', where the landowner/farmer had planted vegetables in the riverbed at this location. Therefore, the QHSE Department liaised with the farmer to agree with him/her that s/he would remove the plants prior to the installation of a gabion wall and rip rap to stabilise the riverbanks and riverbed, as shown in Figure 11.

Figure 11: Gabion wall/rip rap to mitigate scour at RVX4-0699

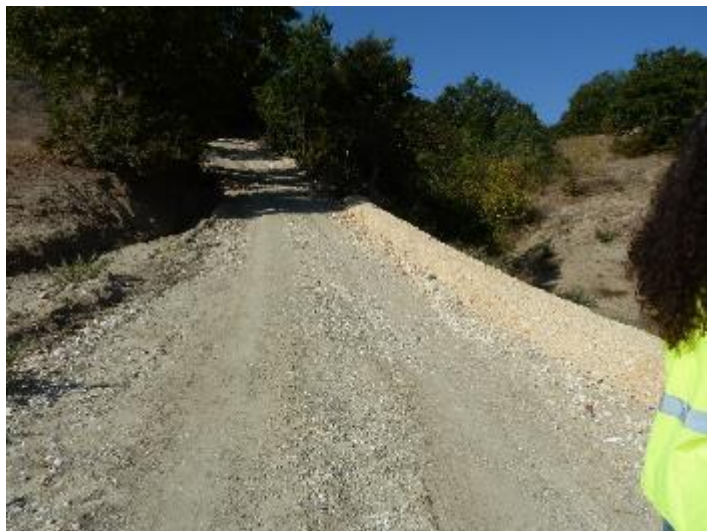
In addition, a small berm was installed along the edge of the access road to divert water away from the steep riverbank and into a natural gully downstream of the crossing point, to help prevent further soil erosion, as shown in Figure 12. Works were completed around 10 months prior to the site visit.

Figure 12: Berm at the top of the riverbank to divert surface water run-off

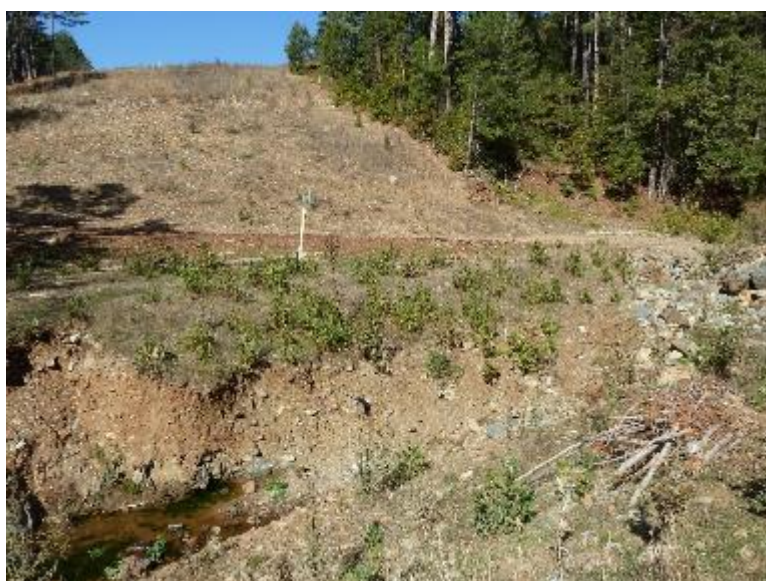
An example of a site where the requirement for remedial action has been identified, but works have not yet been undertaken, is at **RVX4-0700**. A RoW Patrol team first identified an erosion problem at this site 2 years ago. The SME subsequently undertook a more detailed inspection. The survey Report stated that *“Large-sized rocks up to 100 cm diameter are placed upstream of pipeline crossing to connect two valleys. When flood comes, it probably slips over this interconnection (used as a service road). Flow probably applies a force at right bank and bounces back to left bank, implying high amount of discharge and leads to occurrence of big scours. It seems like the river fed by groundwater. Channel cross-section is narrowing*

at pipeline crossing, increasing flow velocity and erosive capacity.” All the results of the surveys were uploaded to the IMP for review by the Integrity Management Department and the decision was taken to install a gabion wall and rip rap at this location to stabilise the crossing point, as per the SME recommendation. Works are due to commence in around a year following a detailed engineering design process, internal budget approval for the works, and a tender process involving at least 2 construction contractors. In the short term, TANAP will undertake temporary maintenance works at this site to protect and straighten the channel using the in-situ rocks and unblock the channel downstream of the river crossing point, which has been filled in by forestry workers to provide access.

Figure 13: Bank erosion and scouring at RVX4-0700

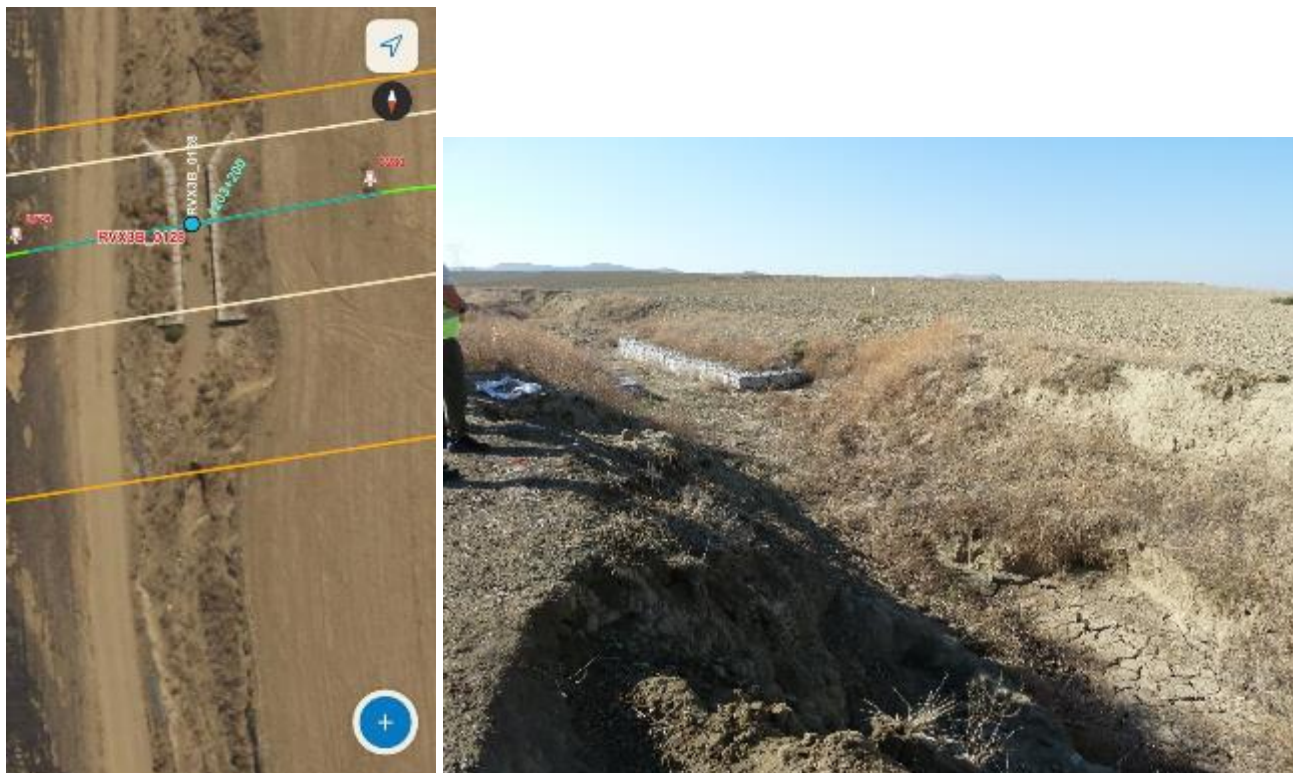
An example of a potential integrity risk that is being closely monitored by the Integrity Management Department is at **RVX3B-0128**. A gabion wall was installed on each bank of the river at the crossing point during the construction phase in 2017, and which continues under the riverbed. Through regular monitoring, TANAP has identified some scouring downstream of the crossing point, as can be seen in Figure 14 below.

Figure 14: Scouring downstream of RVX3B-0128

This site is categorised as having low risk and as such, is only subject to SME monitoring every 3 years. Currently, the area of erosion is far enough downstream of the river crossing point to not be an issue, and the pipe is buried 3m beneath the crossing. However, the RoW Patrol teams will monitor this site every 15 days and if they observe that the area of scouring is expanding upstream, or the riverbanks are being undercut to the extent that the integrity of the pipeline is at risk, this will immediately be flagged to the Integrity Management Department through the IMP.

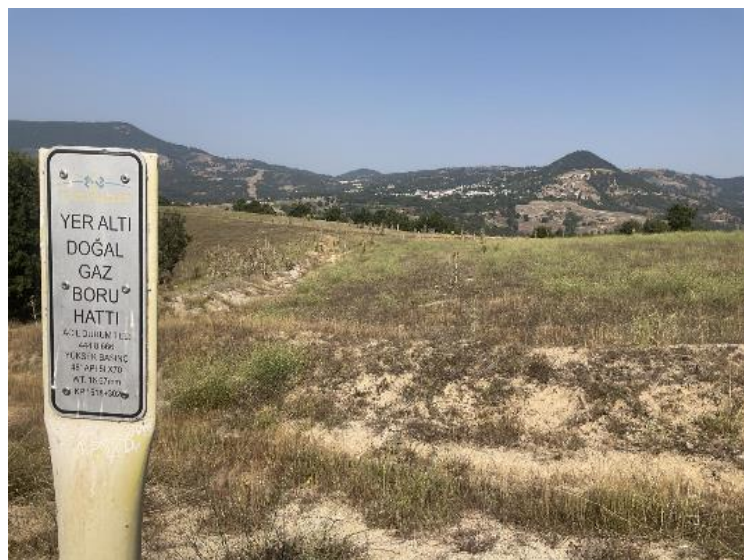
During the 2022 site visit, the IESC observed significant ongoing soil erosion issues at **KP 1518+302**. The main contributing factors to high soil erosion risk at this site include soil composed of weathered granite (with a very high erosion potential) and a small river crossing parallel to the RoW. Furthermore, whilst there is a natural gully at the foot of the lateral slope that would be the most effective way to direct run-off/drainage from the RoW, it is within Government-controlled forestry land and TANAP was not (at the time of the 2022 visit) permitted to divert water from the RoW into this gully. Despite extensive, recent rectification works at this site at the time of the visit in 2022 (including the slope being fully regraded, the slope breakers being repaired and extended, and additional slope breakers being added) the repaired slope breakers had already been breached, and there were clear signs of rilling and deep gullies forming. The IESC recommended that TANAP negotiated with the relevant Directorate of Forestry to allow surface run-off to be discharged into the natural gully, thereby following the natural contours of the slope and resulting in lower rates of soil erosion. Following discussions with the Directorate, TANAP was subsequently given permission to divert surface run-off into the gully, which should have at least partially

reduced the soil erosion risk at this site. Further repairs were also completed in 2023. This site was not visited during 2024 and as such, the current status of soil erosion cannot be verified. However, photographs taken by the RoW Patrol Team in July 2024 were provided for review, which appears to show a more stable situation with no breaches of the slope breakers and good revegetation rates as illustrated in Figure 15.

Figure 15: Status of soil erosion at KP 1518+302

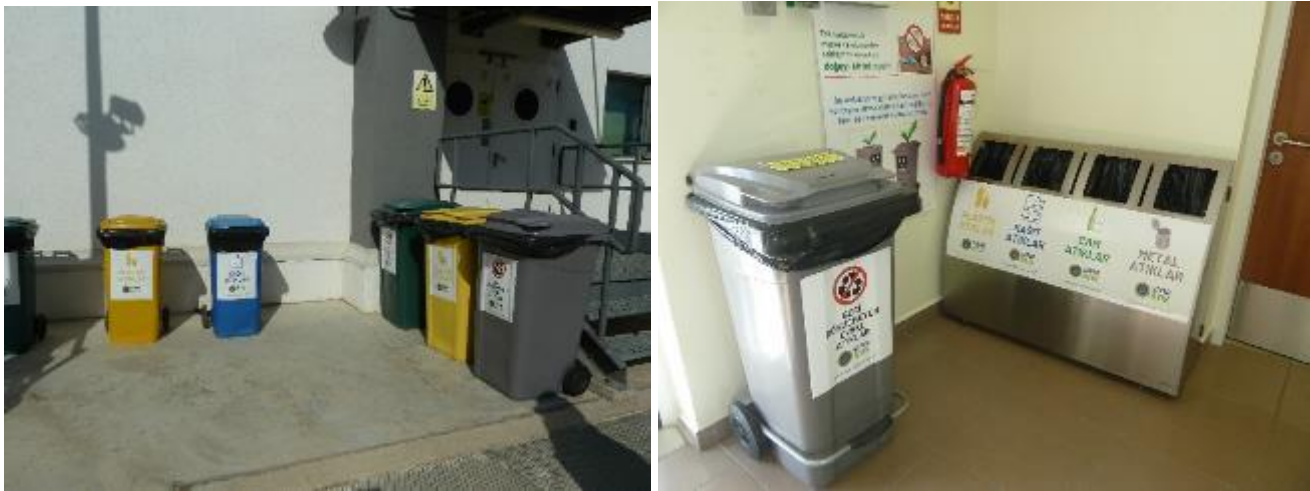
TANAP has the ability to recycle all waste streams from MS4. To facilitate this, a sufficient number of segregated waste bins, with lids, are being provided around the station (inside and outside) for paper, plastic, glass and metal. They were clearly labelled (including to show the Zero Waste Certification), as shown in Figure 16, and there was no mixing of waste types observed within the bins. Such effective at-source segregation is commended.

Figure 16: Segregated waste bins at MS4

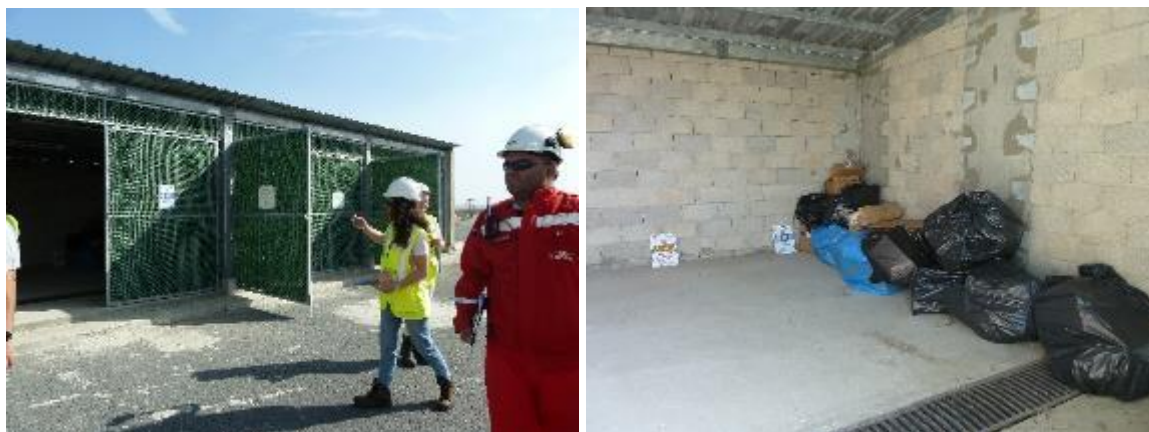
The main temporary waste storage area is located outside the station fence to allow licensed third-party waste disposal contractors to access it. This comprises separate units for different waste streams that are all locked and covered, with impermeable flooring. The contents of each unit are clearly labelled, and good housekeeping practices were being demonstrated, as shown in Figure 17. The only minor observation was that the label for 'Glass' was only in Turkish (not additionally in English), but the Senior Environmental Engineer on the visit was aware of this and was in the process of getting it rectified.

Figure 17: External temporary waste storage area at MS4

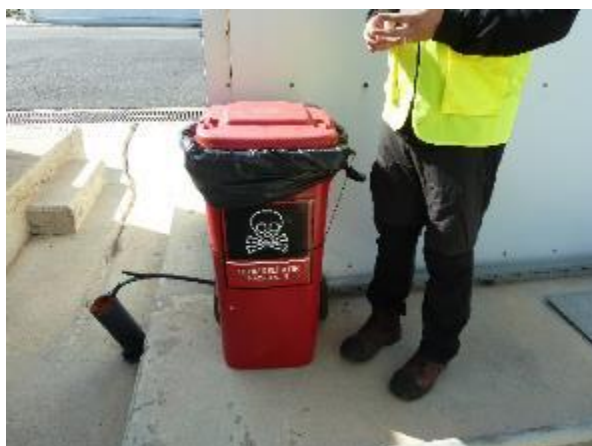
The IESC did not observe a dedicated hazardous waste storage area at MS4. There was at least one hazardous waste bin located next to the wastewater treatment plant (as shown in Figure 18), which the IESC was informed is used for contaminated cloths or gloves and represented best practice (i.e. had a lid and was clearly labelled). It is therefore assumed that the station does not generate significant quantities of hazardous waste and as such, does not require a hazardous waste storage area.

Figure 18: Hazardous waste bin at MS4

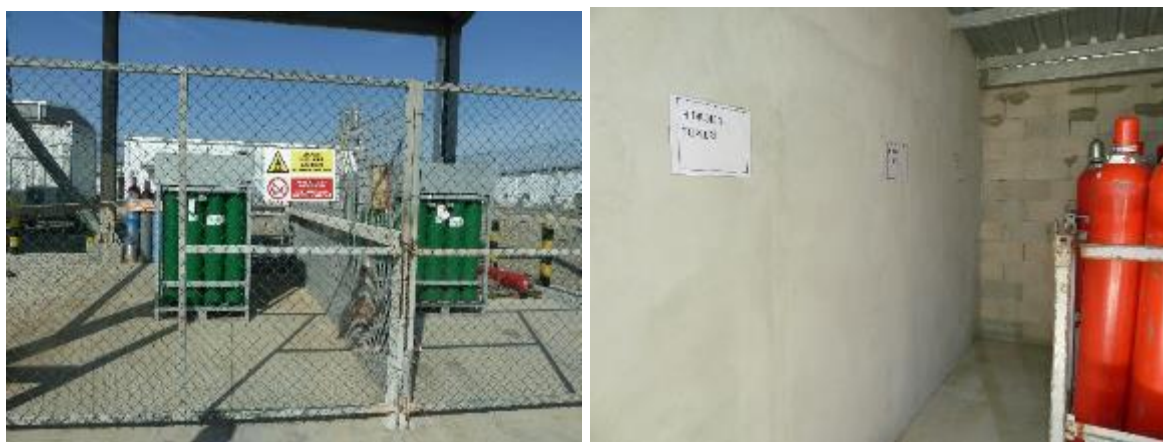
There were 2 dedicated areas for the storage of compressed gas cylinders, the second being a temporary 'overflow' storage area as additional cylinders had been ordered in relation to the planned Turnaround (TAR) or shutdown of the pipeline in August 2024, which provided an opportunity for maintenance activities to be undertaken that required compressed gas. Both storage areas were clearly labelled (in Turkish and English), covered and locked. Material Safety Data Sheets (MSDS) were easily accessible, and the cylinders were stored in groups according to their contents, which were clearly indicated by labels on the walls. This is illustrated in Figure 19 below.

Figure 19: Best practice storage of compressed gas at MS4

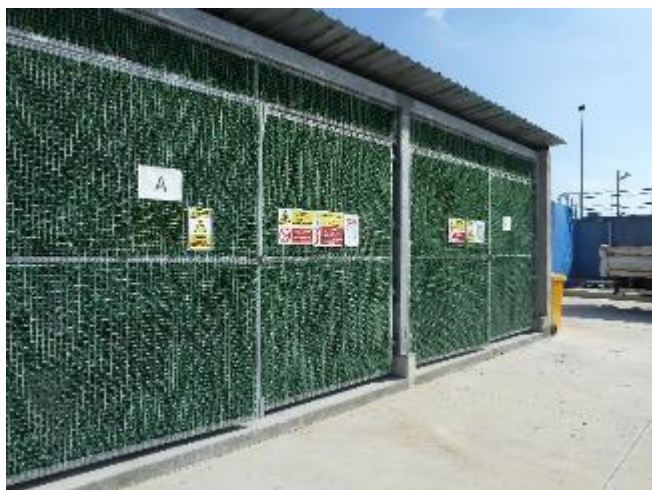
The dedicated hazardous materials storage facility was divided into two halves, for chemicals (A) and oils (B), as shown in Figure 20.

Figure 20: Dedicated hazardous materials storage area at MS4

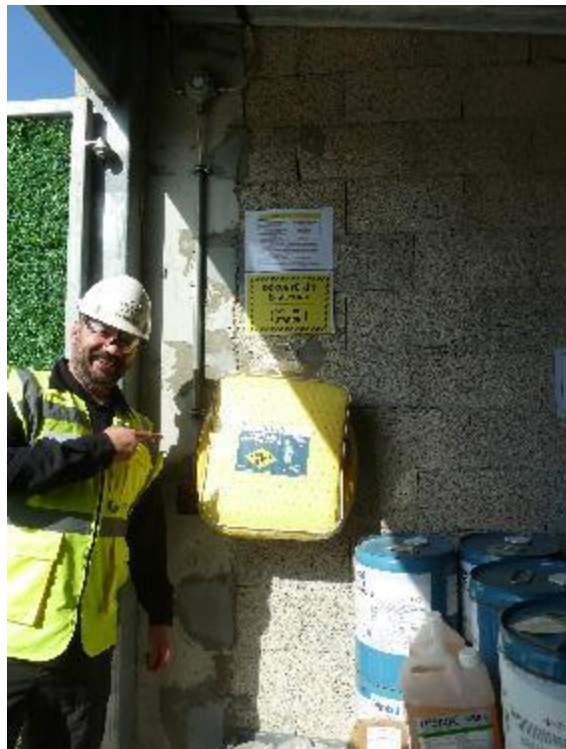
This is a covered and locked facility, and the contents were clearly labelled as being hazardous. There were also compatibility risk matrices posted on each of the main doors, and folders containing the relevant MSDS for all materials were easily accessible within each of the storage rooms. Adequately and appropriately stocked spill kits were provided within each of the rooms, as shown in Figure 21, as well as an additional spill kit located immediately outside the facility.

Figure 21: Provision of spill kits within the hazardous materials storage facility

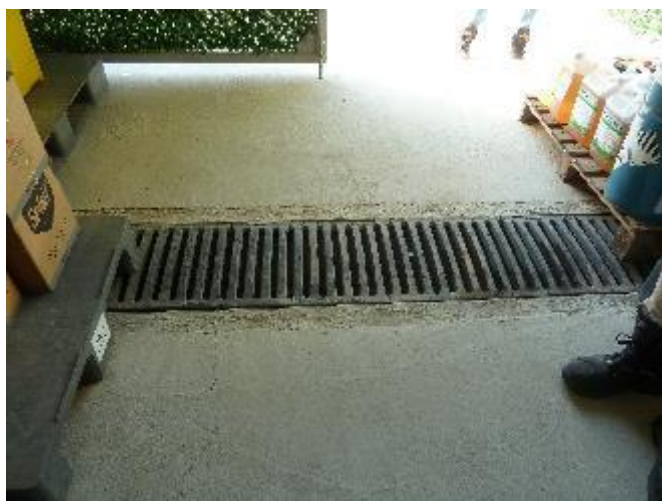
The only minor observation was that none of the liquids were being stored within secondary containment. The IESC acknowledges that the floors in both rooms are impermeable and that a closed drainage system has been installed (as shown in Figure 22) that would divert any major spills into a dedicated tank outside the storage facility. This tank is equipped with a sensor that indicates when the tank requires emptying by a licensed hazardous waste contractor. However, it is best practice for all hazardous liquids to be stored within secondary containment, to ensure that any leaks/spills are contained and do not generate a health & safety risk (e.g. a slip hazard). This will not be raised as a non-compliance, but it is recommended that TANAP considers the provision of drip trays for all hazardous liquids.

Figure 22: Closed drainage

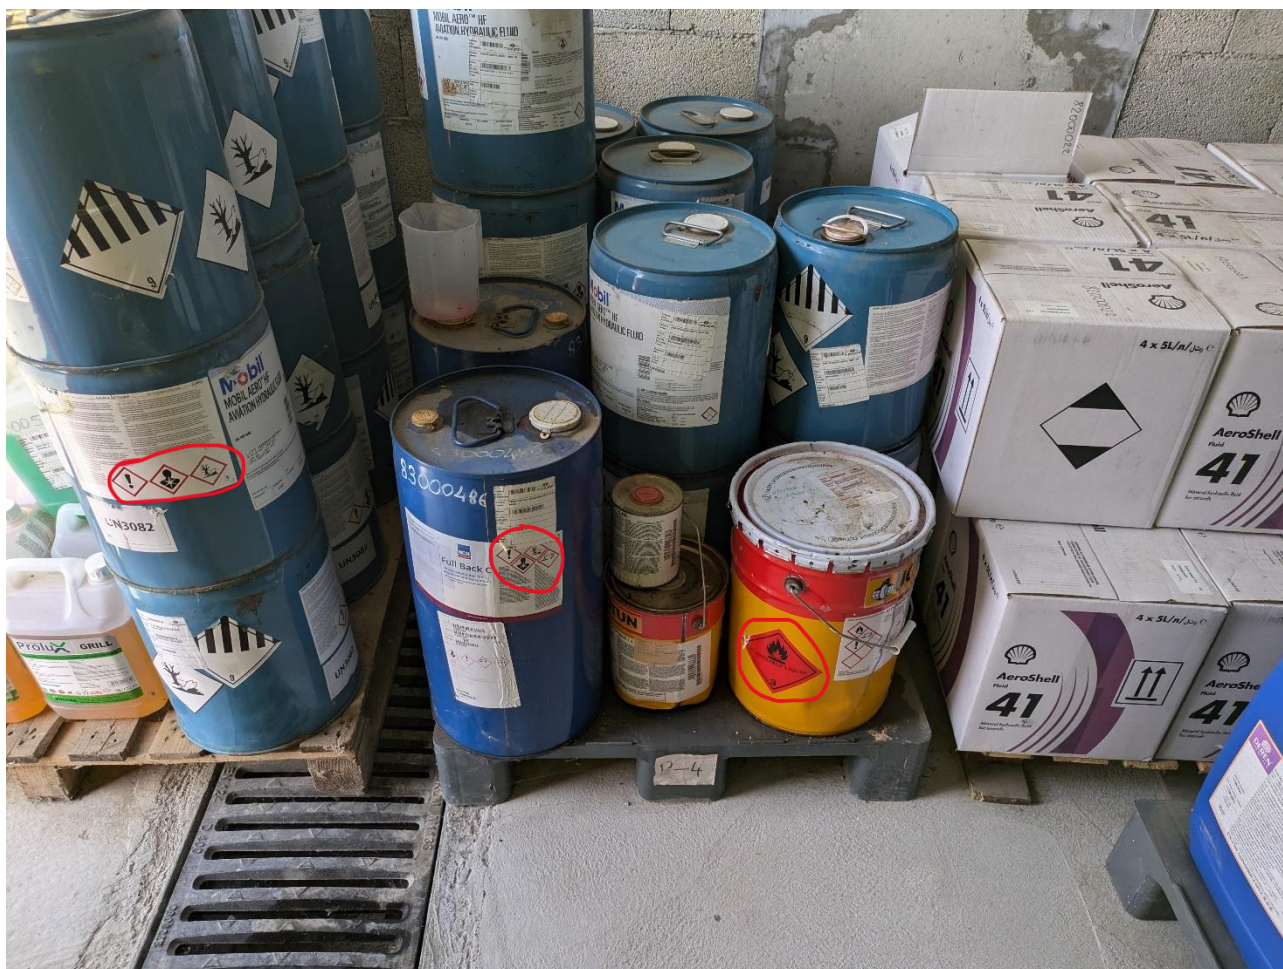
2.2 (2.5.3.5)	Hazardous chemicals at MS4 were stored together when they should have been segregated. This follows on from a similar finding at CS3 last year.	<ol style="list-style-type: none"> 1. The IESC would recommend that all chemical storage matrix sheets across the project be updated to a more easily identifiable version 2. The IESC recommends that the inspection checklist be updated to include a question such as 'have the stored chemicals been checked against the storage matrix to ensure appropriate separation?' 	PC	PR2 / PS2 OHS	Open While not an official recommendation, a review of the training provided to the workers who were responsible for chemicals may be conducted to investigate why the training did not result in compliance actions.

Several instances of flammables, poisons and corrosives being stored together were identified (example in Figure 23). A chemical storage matrix was available on the door of the storage container that states these chemicals should not be stored together. However, it was not easily identifiable as the hazard symbols on the matrix did not match the hazard symbols on the containers.

Figure 23: Example of incorrect chemical storage at MS4. Left: poison and environmental hazard. Middle: poison, corrosive and environmental hazard. Right: Flammable liquid.

Storing poisons and flammables together is a significant OHS hazard. If these chemicals mix, they can create a variety of dangerous situations, including:
