IESCs Monitoring Report October 2023			SPL-REP-HSE-GEN-007
Revision: P6-1	Status: Re-IAA	Date: 24.10.2023	Page 5 of 99

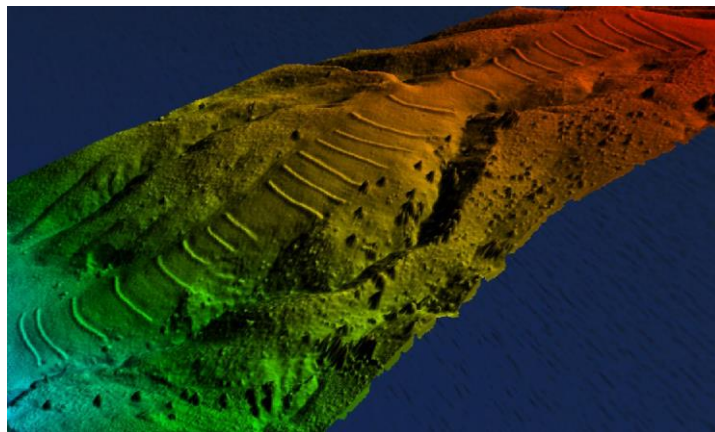
Figure 2.5 Example of a 3D Terrain Model of the RoW

An aerial survey by plane of a 500m corridor along the entire pipeline route was completed in Q4 2022 and TANAP has been processing and analyzing the imagery obtained since January 2023. It is intended that this survey is repeated every 3 years for comparative purposes, depending on the available budget. TANAP has also completed a photogrammetric inspection of the majority of the RoW using drones equipped with Lidar features. Flying restrictions (such as battery life, military zones, airports) have prevented the entire RoW from being photographed by drone, however, the resulting images have helped to facilitate the generation of high-resolution 3D terrain models of the pipeline route, such as the example in Figure 2.4, to help detect any changes in ground elevation, surface conditions and RoW violations. These 3D terrain models are also helping to assess complaints from landowners/stakeholders regarding reinstatement, by enabling a comparison of the RoW before and after construction to identify any topographical anomalies.

Drones have also been used by TANAP for event analysis, e.g. following flood events or earthquakes to record video footage that can be inspected to detect any new risks to the integrity of the pipeline that require a more detailed in person site visit.

The results of all aerial and drone surveys are input to the IMP, to help ensure that TANAP has an up-to-date overview of the condition of the RoW.

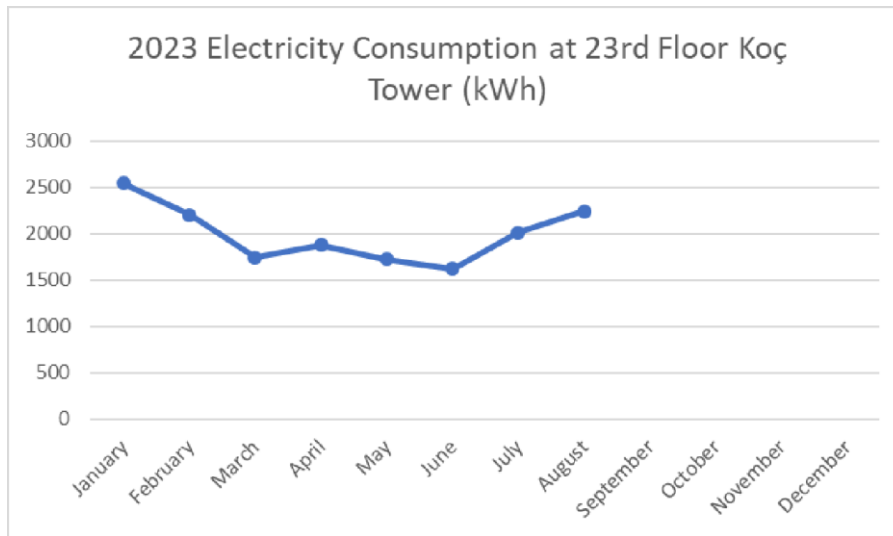
Figure 2.6 Electricity consumption for 23rd Floor of Head Office in Ankara (2023)

In order to achieve annual savings in electricity consumption, TANAP has initiated an IT campaign including making e-mail announcements and issuing computer screen pop-ups to remind employees to adopt energy saving behaviours. Additionally, reminders are being issued during meetings, and on the 23rd Floor of the Head Office building in Ankara, a pilot scheme to automate the lighting has been implemented. If this is successful, it will be expanded to the rest of the building and other facilities. Since January, there has been an overall decrease in electricity consumption as illustrated in Figure 2.6, which implies that the pilot scheme is having a positive effect.

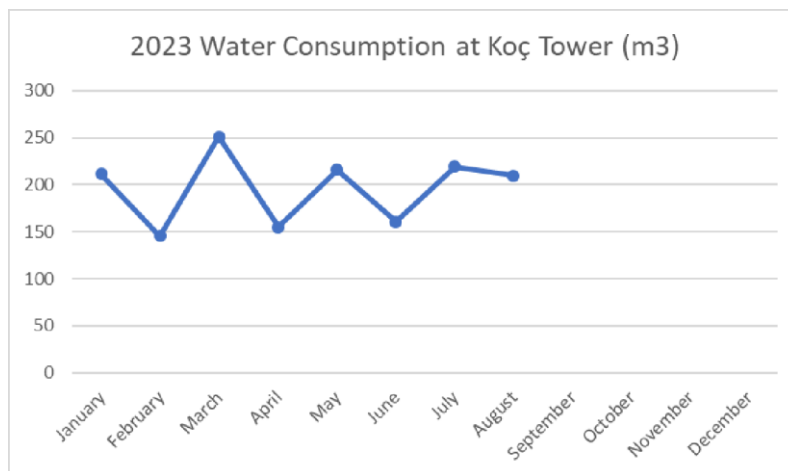
Figure 2.7 Water consumption for Head Office in Ankara (2023)

TANAP has already implemented water saving measures but is attempting to identify further methods for reducing water consumption. Figure 2.6 below illustrates the impact of a change in the number of people being in the office, or out of the office on site, which suggests that reducing the water pressure or introducing flow rate limiting devices on taps will help to achieve the target improvements.

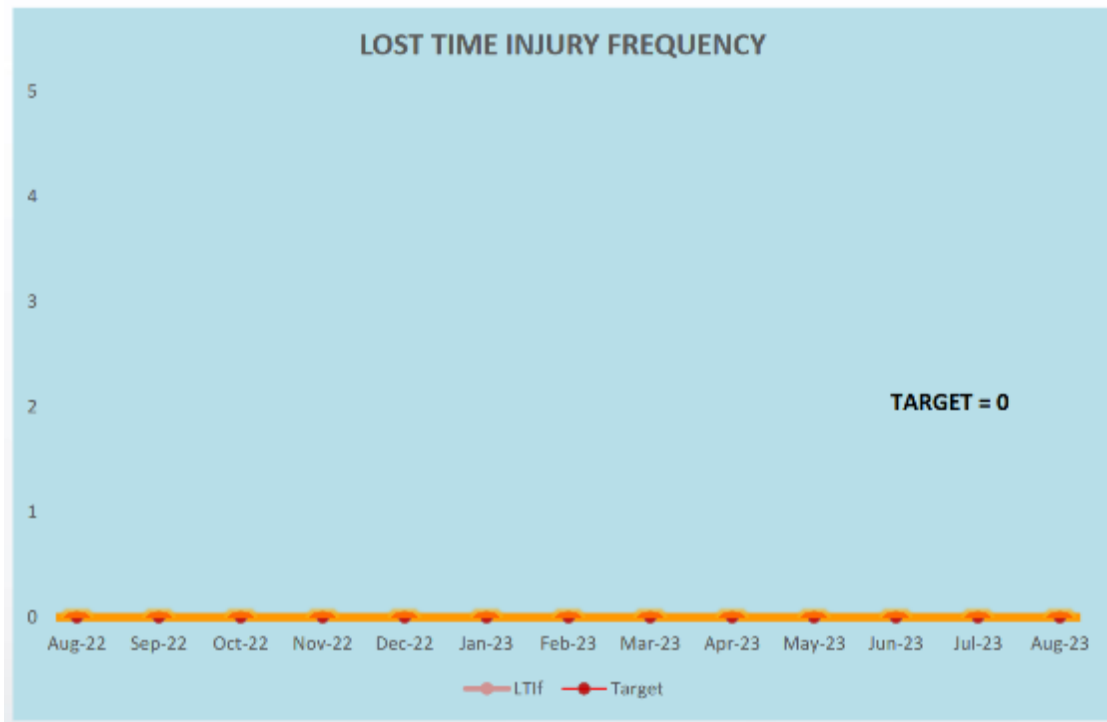
Figure 2.22 Lost Time Injury Frequency

The incident register was reviewed and is to be commended with zero recordable incidents for the monitoring period. There were no High risk near misses for the period under review and as noted in this report the lagging safety statistics for this project are excellent and industry best practice. Lagging safety statistics are presented below and actual LTI frequency and total recordable injury rate are below the respective targets of 0 and 0.3 for the entire monitoring period.
