IESCs Monitoring Report October 2022			SPL-REP-HSE-GEN-006
Revision: P6-0	Status: IAA	Date: 31.10.2022	Page 1 of 96

<p><b>TANAP</b></p> <p><b>TRANS ANATOLIAN NATURAL GAS</b></p> <p><b>PIPELINE PROJECT</b></p>

## IESC Monitoring Report October 2022

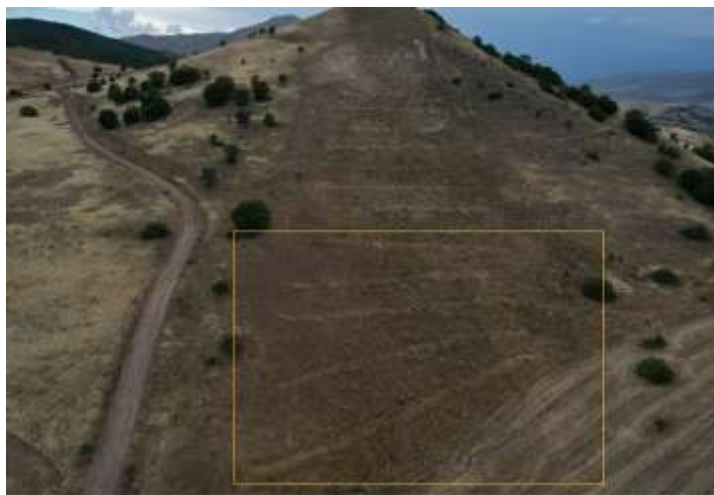
Figure 2.24: Permanent land acquisition of slope breakers (example)

Additional land acquisition for operational works is ongoing, with a current focus on expropriation of land for slope breakers. Following geohazards investigation (by consultant, Temelsu) of 40 complaint records, land on which slope breakers are located are being permanently acquired in two cases. For example, the figure below shows a photograph from a completed site investigation in the MS1-CS1 area. Following the investigation, the slope breakers on the upper part of the hill were recommended by the geohazards consultant to remain in place and be permanently acquired, while those in the yellow area were identified for removal.
