IESCs Monitoring Report October 2024			SST-REP-HSE-GEN-001
Revision: P6-0	Status: IAA	Date: 18.11.2024	Page 4 of 94

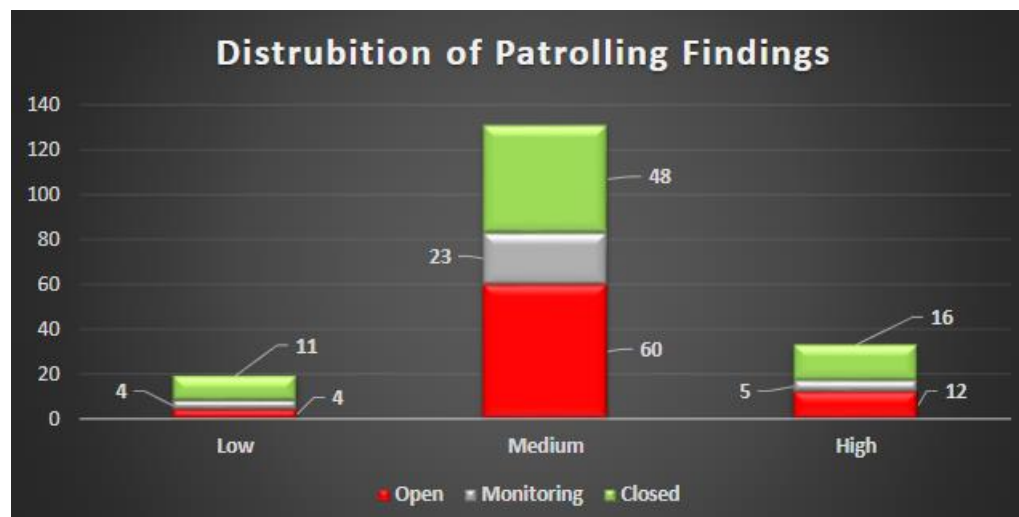
Figure 6: 2024 RoW Patrol Findings

From January to September 2024, the RoW Patrol Teams reported 183 findings, of which 33 were high priority (for example pipeline subsidence or unauthorized excavations), as shown in Figure 6.

In terms of the top three findings, only 31 related to the planting of trees on the right of way (a medium priority issue), which is an improvement compared to 2023 when there were 150 findings of this type. 35 findings were related to damaged or leaning line markers/aerial markers, and 42 were due to BVS/Station access road damage and traffic sign damage.
